# THE CANARD PUSHER

No. 35

January 1983

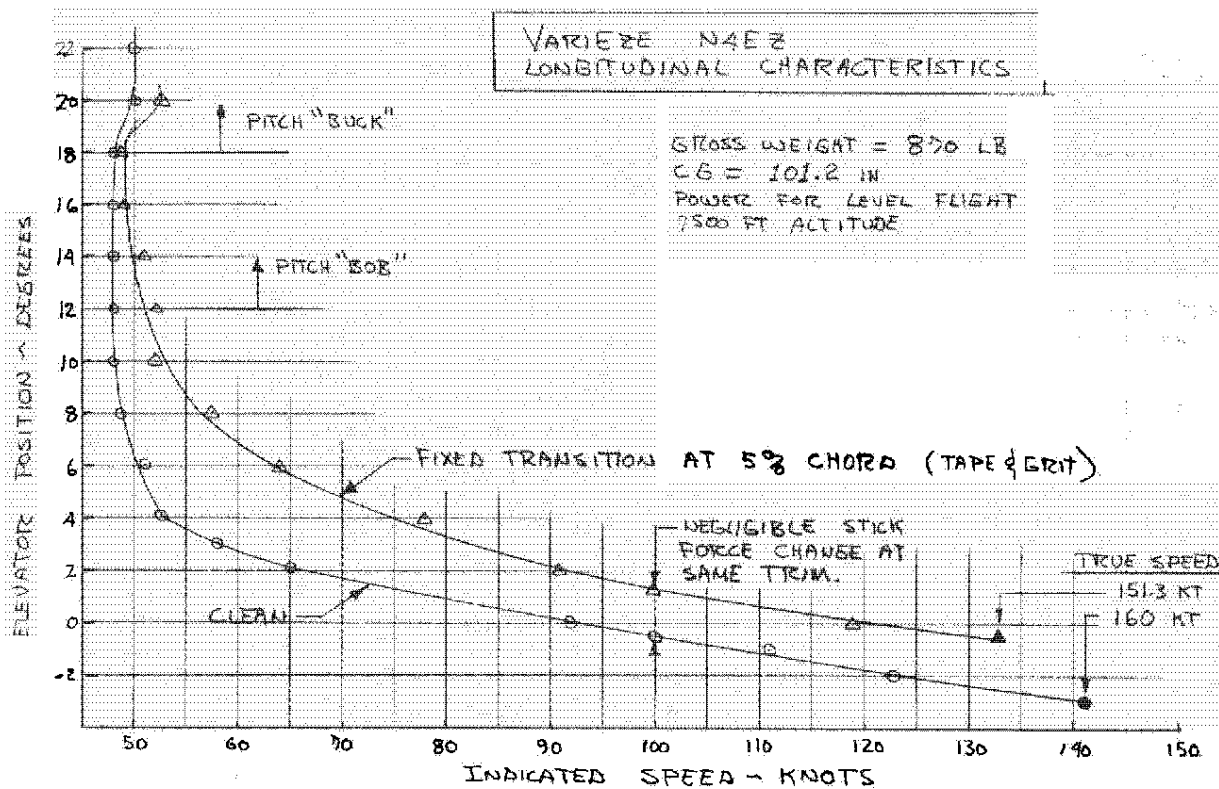
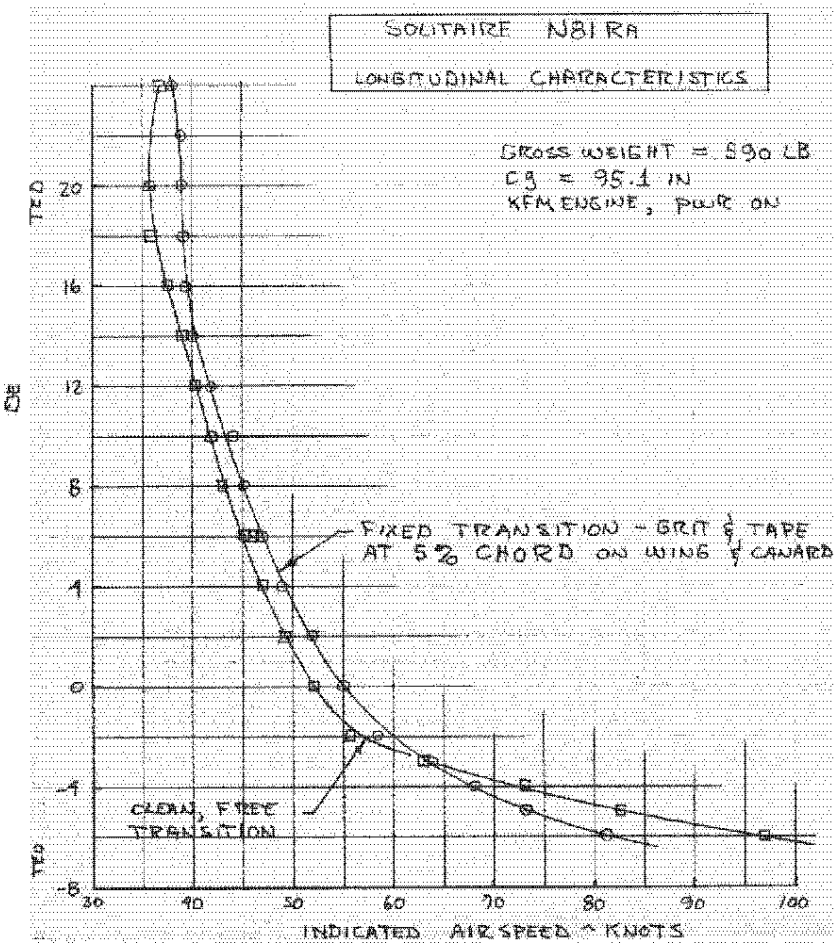
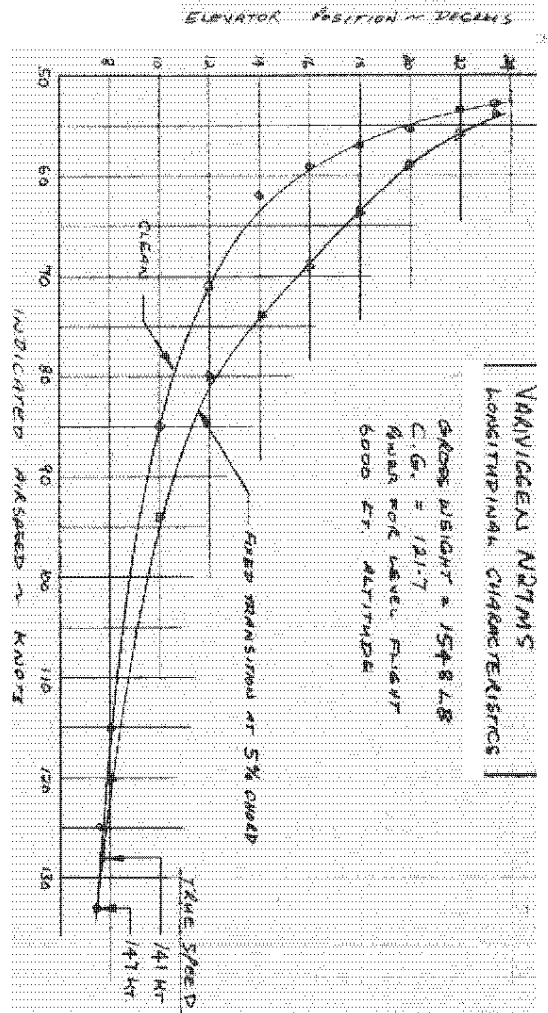
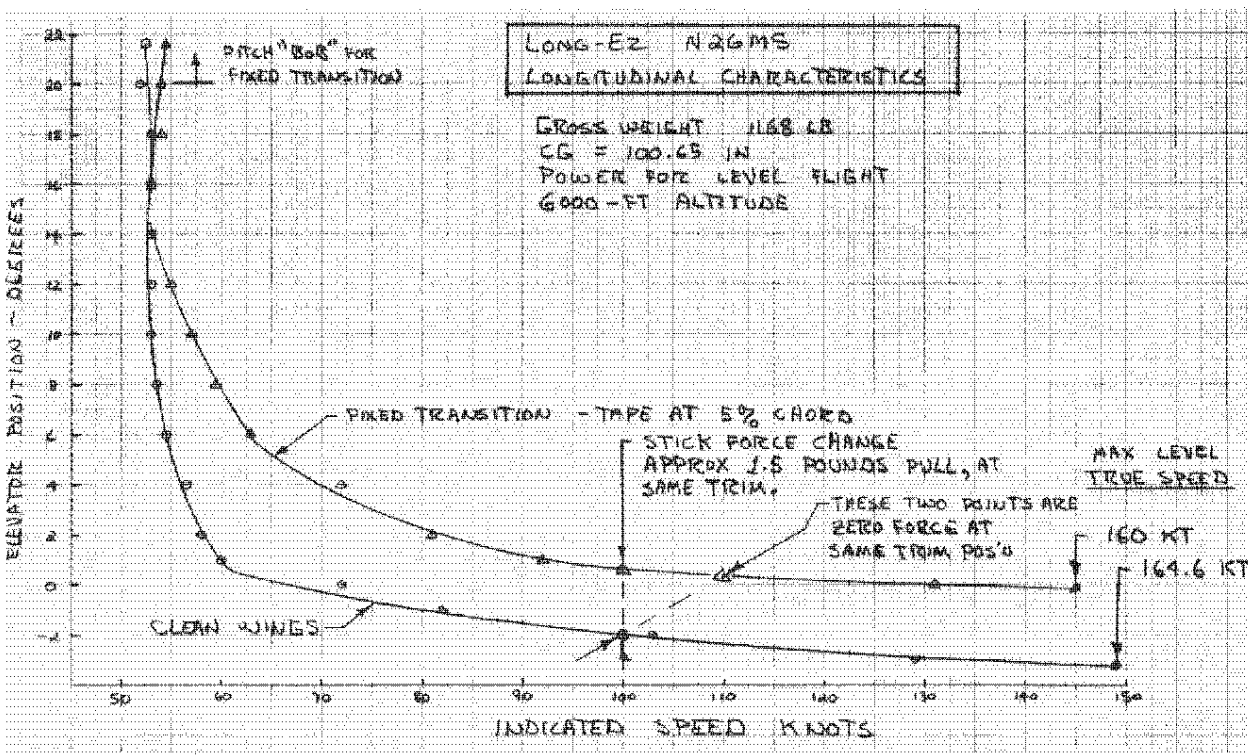
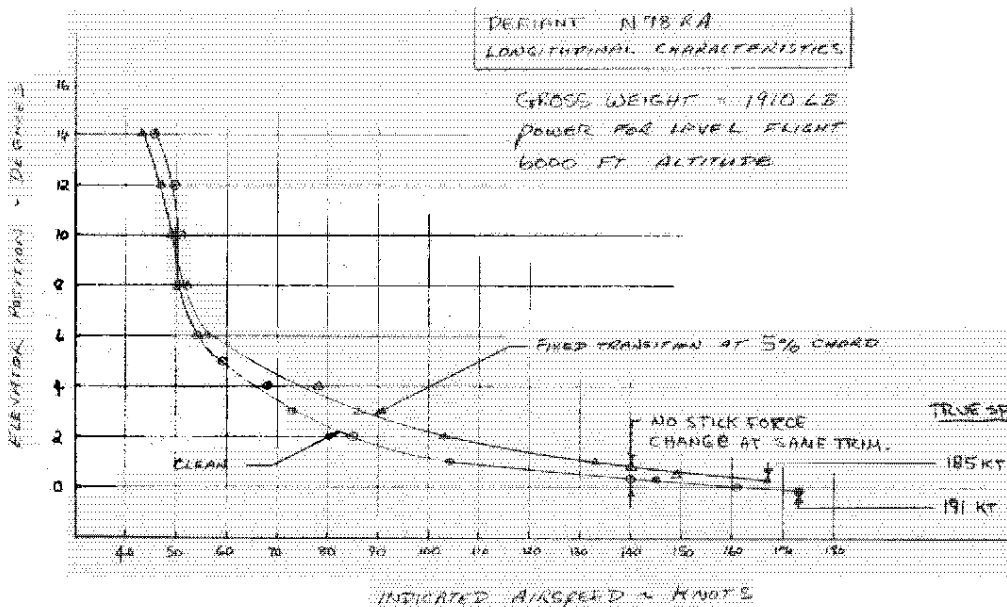
We instrumented the VariEze prototype, N4EZ with an accurate elevator position indicator and gathered the elevator position versus speed data shown in the adjacent plot. Upon landing we applied grit and tape to the aircraft flying surfaces, wing and canard to provide a positive transition of the boundary layer at 5% of chord. This consisted of adding a "step" to the otherwise smooth surface of the airfoil that was sufficient to destroy all the laminar flow, a condition caused by either an accumulation of insects on the leading edge, or flight in rain. We then added the fuel used during the first flight to bring the airplane back to the same exact gross weight and cg and flew again gathering the same elevator position data. As shown in the adjacent plot the elevator position required to achieve a given indicated speed was greater than with the smooth surfaces. It should be emphasized though, that the trim change that the pilot feels is not the same as the shifted elevator position since the transitioned boundary layer alters the pressure distribution around the elevator. Even though the elevator is more trailing edge down it does not necessarily result in an aft stick force. In the case of the VariEze N4EZ, the trim change due to the trim change transition (the force required to fly the airplane without adjusting the trim lever) is extremely small and is for most of the flight regime not noticeable as a nose down trim change.

The NASA concern for a greatly increased stall speed, was not achieved as you can see from the data, the minimum speed achieved with the transitioned aircraft was higher, but only by approximately 1 to 2 knots.

Note that transitioning the boundary layer did not change the highly desirable shape of these curves, it only resulted in a minor increase in the minimum speed. Looking at the high speed end of the same plot shows that tripping the boundary layer did have a significant effect on the airplane's maximum speed. Reducing the surface deterioration reduced the maximum speed by nearly 9 knots. This is a significant increase in drag of approximately 20%.

Referring now to the data of Long-EZ N26MS, a definite shift in elevator position is apparent at all normal speeds. After collecting the clean data the aircraft was trimmed to 100 knots 'hands off'. Then, without changing pitch trim, it was landed, the tape applied, and the fuel burned was replaced to keep cg and gross weight identical. It was then flown back to 100 knots. Data show a 2 1/2° shift in elevator position and the pilot reported a 1 1/2 lb. pull force. Then, without changing trim, the aircraft was flown to 110 knots where it was again 'hands off' i.e. no stick force. Note that the force was the same (zero) even though the position was 2.2° different.

Turning now to the Solitaire data, the pilot of the Solitaire could not feel any stick force trim change when operating between clean conditions and flying through rain showers. The transition elevator data, however, do show a minor trailing edge down trim change at speeds below 63 knots and trailing-edge-up trim change when faster than 63 knots. Remember, however that this is elevator position rather than stick force data and the changes seen here were not significant enough to be noticed by the pilot. As in the VariEze the minimum speed achieved when the surfaces were deteriorated with grit and tape were approximately 2 knots faster. The gliding performance was degraded considerably when the boundary layer was transitioned. The data shown are for powered flight with the self launch engine running at a constant power. A similar change is experienced during gliding flight except that the transition trim change "cross over" speed is reduced from 63 knots to 60 knots. With power off, the minimum speed achieved on the clean Solitaire is within 1 knot of that achieved with fixed transition. Note that the Solitaire has a relatively high amount of longitudinal stability in that the elevator position changes rapidly with speed changes. This condition results in large elevator deflections (approximately 6 to 8%) required for normal themalling flight. This results in a trim drag that reduces

Referring to the Defiant data, tests show that with identical trim settings there was no stick force change due to fixed transition. Interestingly, the minimum speed with tape applied was less, probably due to the fact that the wing was more effected by the transition than the canard. This would result in a higher trim angle-of-attack.

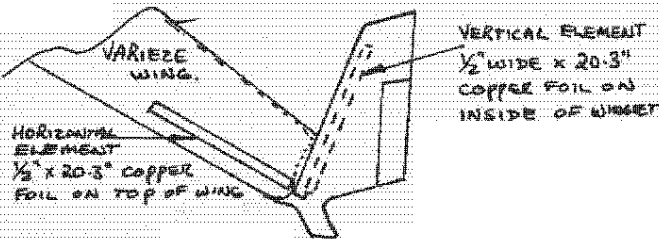
"NO ANTENNA FOIL ON THE GEAR LEGS. NONE, NO HOW, NO WAY. Get the idea? There have been a series of reports that the gear-leg antennas work very well when first installed, then gradually deteriorate over time. Actually, the "deterioration" seems most pronounced after a hard landing. The copper foil is not as resilient as the glass, and rather than flexing like the fiberglass, the copper tape breaks. Net result - lousy antenna operation.

On new construction VariEzes the "Long-EZ" comm antenna can be installed on the winglet and outboard wing as shown. Follow the instructions in CP 26, page 7 for the Long-Ez comm antenna.

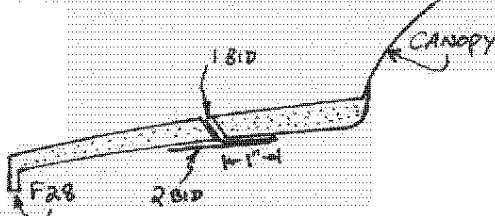
Mike recently installed a "drip tray" around the front cover to canopy joint, which really does a job on keeping moisture out of the avionics, even in driving rain.

This is tough to install as a retrofit but can be done easily at the time of the original construction.

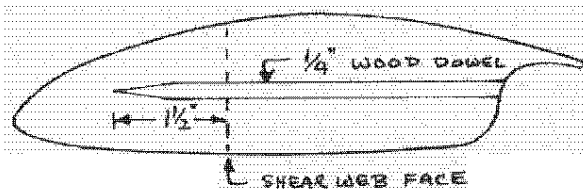
Builder support on canards has been quite heavy, particularly in regards to getting the leading edge foam core bonded to the shear web, on the two inboard cores, in the correct position, vertically. If this is bonded on too low (relative to the airplane) the result will be a hollow lower spar cap and a bump in the top spar cap. This bump in the top cap is a problem, since it cannot be corrected. If yours is this way, our experience has shown that a small error here can usually be accepted provided a good job of filling with dry micro and fairing is done. The worst of this problem will be buried within the fuselage under the canard fairing block and usually will not extend much more than 10" to 15" outboard of the fuselage sides. A bump of up to 1/16" at the fuselage side, tapering to nothing at B.L. 25 each side, has not been detrimental to flying qualities.

Insert these dowels equally spaced into the trailing edge of the two inboard cores as shown. Push them into the foam, twisting them with your fingers. They should protrude beyond the shear web cut line by about 1 1/2". Now pull the dowels out and hot wire cut the leading edge foam cores at the shear web.

Jig the inboard cores, and layup the shearweb per plans. After this layup cures, drill 1/4" holes through the shearweb in 6 places where the dowels will go through (use a flashlight to locate the holes). Now bond the leading edge foam cores to the shearweb per plans, using micro. Paint micro onto the dowels and push all 6 of them in, until they are flush with the aft face of the canard. Complete the canard per plans. The dowels will guarantee that the leading edge foam cores are perfectly aligned and your spar troughs will be correct top and bottom. We recently built a canard using this method and ended up with a really nice contour, top and bottom, with no bump or hollow place in the spar cap area. Try it, you'll like it!

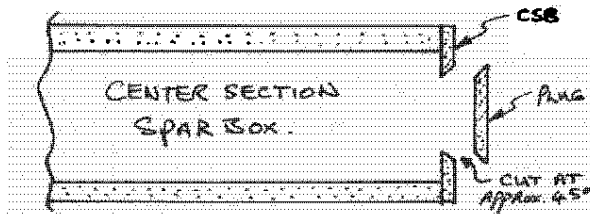
centersection spar, or on the fuselage side. A sure fire method to locate these leaks is to use a "Freon Gas Sniffer". These expensive gadgets can usually be borrowed from your local friendly auto airconditioning repair man. Simply spray a little Freon into the offending tank, pressurize it by raising the altimeter no more than 1500 feet. The Freon sniffer will quickly locate the leak. If the leak is inside the center section spar, you may have to cut through a CS5, CS6, CS7, or CS8 bulkhead. Cut a plug no bigger than you have to, to get your hand through. Cut the plug out at an angle so the plug can easily be floxed back in place.

Repair with two plies BID lapping at least 1" onto the remaining panel. Now that you have the exact location of the leak, you can suck a 1500 ft. lower than ambient pressure, causing a slight vacuum. Paint warm epoxy over the leak area, working it in with a brush or rag. Do this for a couple of minutes. Then open the tank to ambient pressure. This is most important, since the epoxy that was drawn into the leak, would continue to be drawn in until the leak was once again there. You want the epoxy to cure in the leak area.
