THE CANARD PUSHER

No. 53

Oct. 1987

RUTAN AIRCRAFT FACTORY INC.
Bldg 13, Airport,
Mojave, Ca 93501
(805)824-2645

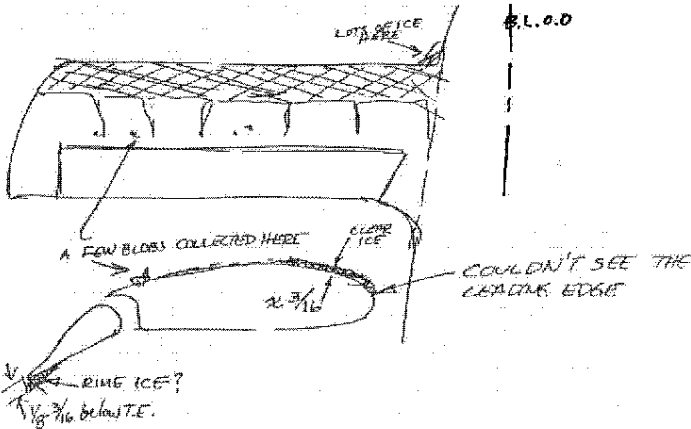
FIG I - ICE DISTRIBUTION ON CANARD & ELEVATORS

I did want to let you know that the plane was flown in heavy rain and, unavoidably, some icing. In both conditions, and even with a thin film of ice or ice droplets on both the leading and trailing edges of the canard and main wing, there was no detectable loss of control or tendency towards stall or loss of lift as we had noted with the earlier canard.

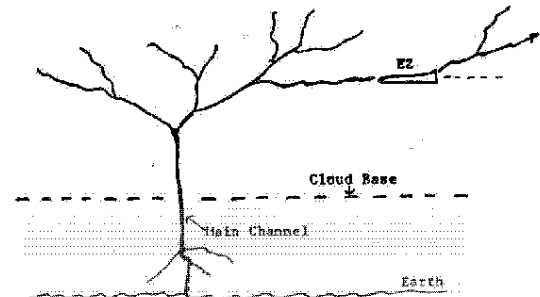
3. The "flash of light" and "loud crack" indicates a lightning strike, although evidently one of mild intensity as indicated by the comparatively minor effects on the aircraft. At 14,000 ft. it is likely that the aircraft encountered a branch of a flash, rather than the main channel of a cloud-to-earth flash; as illustrated in the following sketch.
