THE CANARD PUSHER

No. 57

October, 1988

RUTAN AIRCRAFT FACTORY, INC.

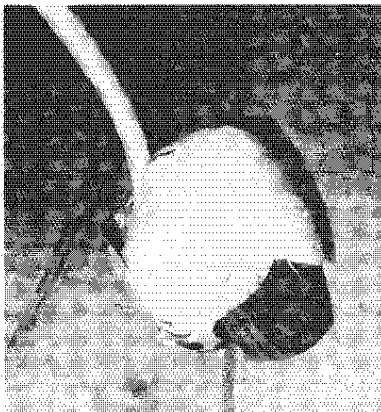
I should digress and describe the failure more thoroughly. Apparently, I had used more braking than I thought during the landing (due to both landing fast and the high idle speed). Also, the other tire was low, which required more right brake. And I had the shimmy damper adjusted too tight, requiring even more brake. Finally, since the Runabout is a bit on the hefty side, I have the big brakes. More heat. The failure was in an arc, the same size and shape as the brake disc, and the mode of failure was resin burnout from direct heating of the brake disc.

Sad but true!- the result of heavy braking & riding a brake.

After returning to Mojave, we repaired the gear strut. A particle board fixture was made for the inboard side of the gear strut, and bonded in place. A body grinder was used to grind away about 2/3 of the S-glass strut at the bottom, tapering to nothing about 12 inches up the strut. Some dry S-glass roving (see your neighborhood Defiant builder) was

The next magical trick was to install a 1/8 thick aluminum plate between the axle and gear strut. This fan-shaped plate extends upward to just above the brake disc, and is intended to protect the strut from the direct radiant heat of the brake disc. The usual Fiberfrax and aluminum tape were reinstalled. The aluminum plate may seem like overkill, but I don't ever want that to happen again.

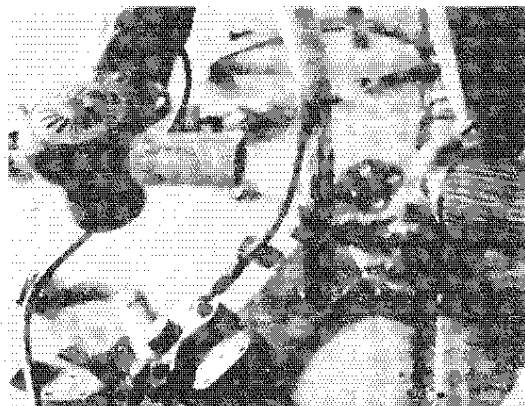
It worked. We had thought ahead and brought two industrial-strength heat guns, and these were mandatory in order to reheat the gear strut to bend it straight, for although the fibers were failed locally, the resin had rehardened to a startling degree.

It took two heat guns to warm the epoxy enough to straighten the strut.

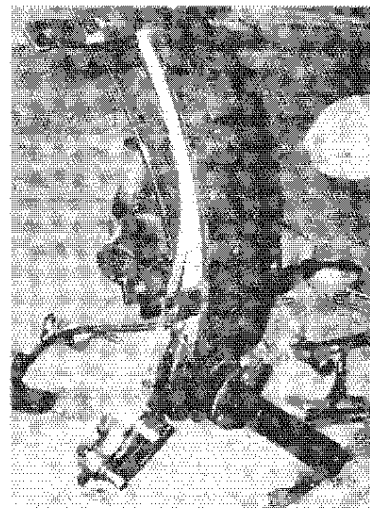
Fitting The Splint!

Mike had made The Splint from some 1/4 inch 4130 steel strap, sort of roughly formed over his right main gear strut. The plan was to remove the axle, bend the strut back straight-ish, and install The splint to sandwich both sides of the gear strut. The axle then would be mounted outboard of the steel piece with longer bolts.

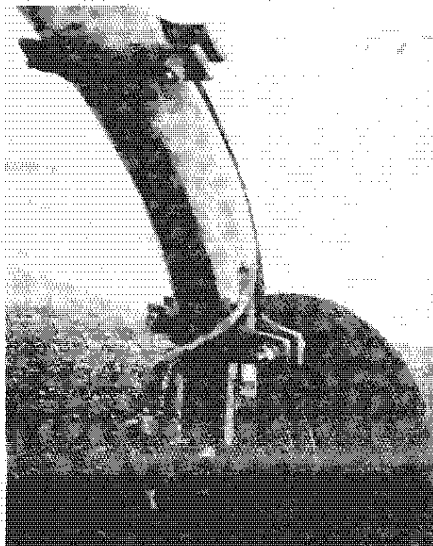
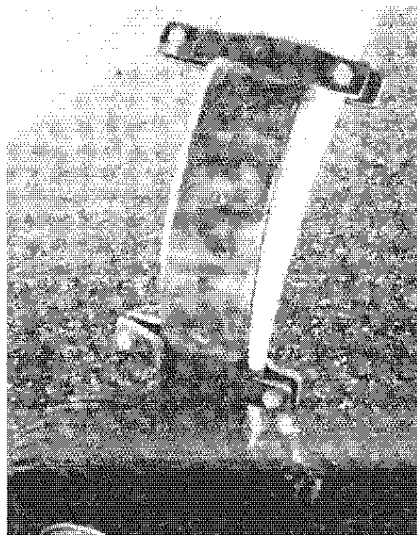
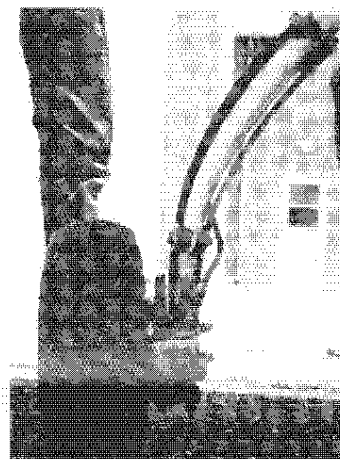
A perfect fit!, incredibly the toe-in was even correct!

The Splint worked admirably. The cylinder change went without difficulty (the piston hadn't broken, and there was no metal in the screens). In fact, the entire time on-site was less than 24 hours. The next afternoon, the Runabout completed her trip east, a cross-country of well over 6000 nm. She had 89.5 hours on the Hobbs (in less than 60 days).

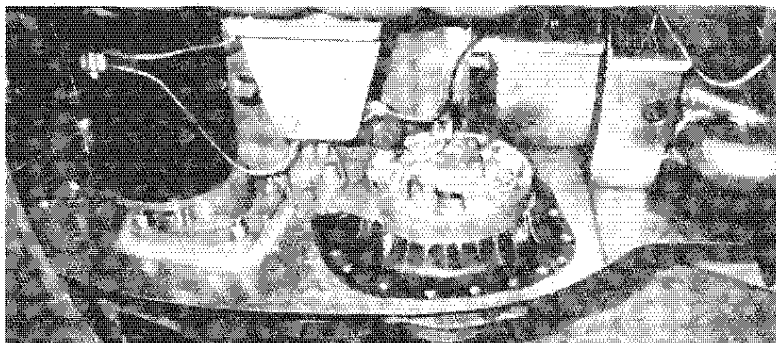
Baffling! .032 6061-T6 aluminum. This is how it should be done. The neoprene/asbestos material still has to be installed.
