# THE CANARD PUSHER

No. 58

Jan., 1989

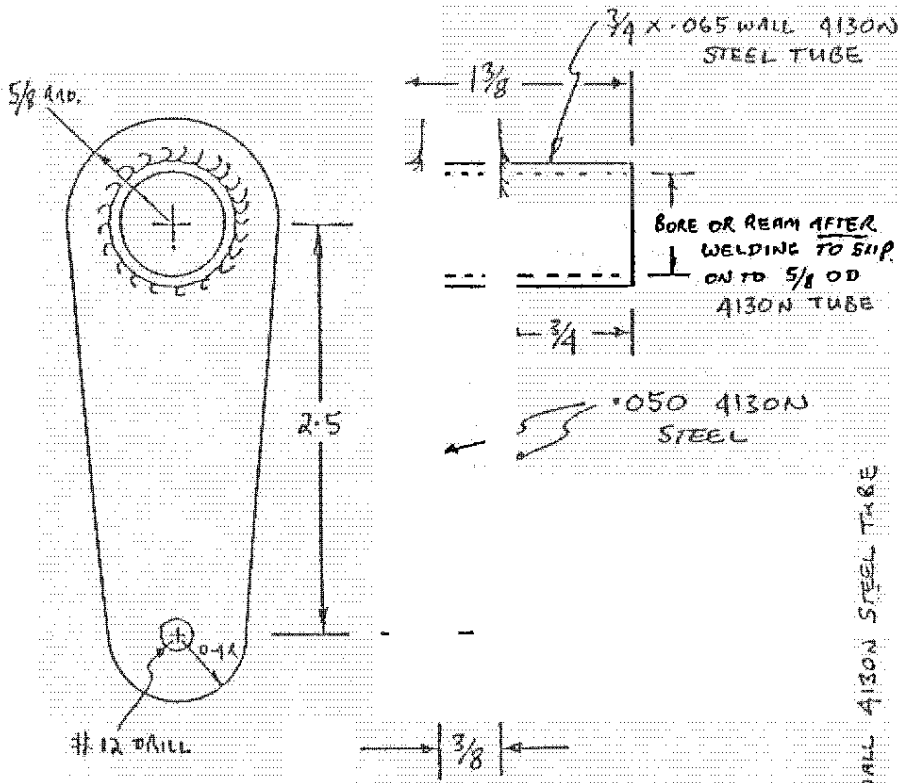
RAF has recently received two separate reports of failures of one of the CS132L weldments, the belhorn, which drives the aileron out in the wing roots. One of these belhorns has had lightening holes bored through the .050 steel belhorn and it cracked through one of these holes. However, the second one was as received from Brock and it cracked across at the edge of the weld around the tube. Prior to the failure of the belhorn this builder pilot had had to replace the rod end that bolts to this belhorn, at least twice over the past 350 flight hours, due to the rod end being "pounded out" until it was dangerously loose.

Why would this belhorn fail on two relatively low time Long-EZs when we have literally dozens of Long-EZs with 1000-plus hours and some with 1500-plus hours with no failures and zero wear on the rod ends? Bill Freeman, Long-EZ builder/flyer and a man whose specialty is working with vibration problems and who has a Master's degree in Mechanical Engineering, has a theory with which we concur. The original control system with aluminum push rod tubes apparently was OK. The natural frequency of this collection of parts was not the same as the normal cruise excitation frequency of the engine/prop. Changing the aluminum tubes to steel as called out in the CP may have moved the control system into the excitation frequency of the engine/prop combination. Bill says that this strongly suggests to him a spanwise vibration of the CS132L belhorn and CS129L pushrod at, or near, its natural frequency, inducing a high-cycle fatigue failure in the CS132L belhorn. The fact that the rod end bearings were beaten out is strongly suggestive of a resonant vibration of the CS132L and CS129L pushrod. This vibration would have the bottom end of CS132L and the aft end of CS129L moving spanwise, bending CS132L in the weak direction with high enough stress levels to initiate a fatigue failure in CS132L.

If you absolutely insist on flying before the new belhorn is replaced, a careful examination of your CS132L belhorns are mandatory. Use a bright light and a magnifying glass. Examine the area shown in the sketch while gently flexing the CS132L

left and right. Any sign of a crack starting requires immediate grounding of the aircraft until the new CS132L-R is installed. Examine the rod ends bolted to the CS132L. Look for a loose ball, or play in the rod end in the fore/aft plane. A worn rod end must be replaced before flight and you should realize from the above discussion that a worn rod end almost certainly indicates that a belhorn failure is imminent. If you have steel tube push rods (CS132L), your belhorns are definitely more suspect. If you have worn rod ends, do not fly until you replace the belhorns and rod ends. Even if everything looks OK, replace belhorns within the next 25 hours of flight. The CAD plated CS132L belhorns should not be painted since the paint may hide a crack.

The new part, part number CS132L-R, has two arms instead of one which will more than quadruple the stiffness of the system and will also provide redundant links in the aileron system as well as providing positive retention of the rod end in the event of a ball slipping out.

MAN-GRD: Long-EZ and VariEze - see section on belhorn failure. Replace aileron belhorns within the next 25 hours of flight. If ailerons are vibrating, you must re-balance.
