THE CANARD PUSHER

No. 61

Oct. 1989

Published quarterly (Jan., April, July, Oct.)
by

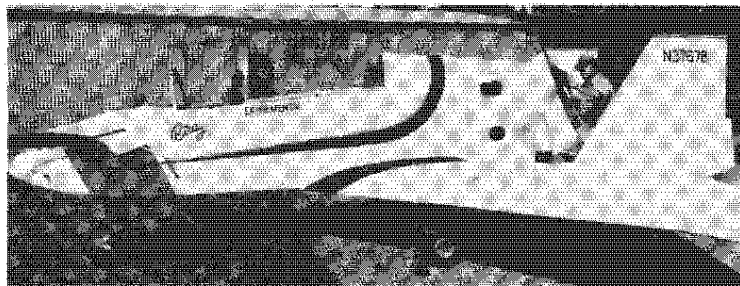
A New York VariViggen crash landed in the Piconic Bay shortly after take-off when the engine quit. The pilot, an experienced Viggen flyer attempted two re-starts but could not get it to run. He then turned into the wind and executed a near perfect gear up water landing.

The Viggen floated and the pilot was quickly rescued by some pleasure boaters. The Viggen was towed to the beach and, after spending some 20 hours in salt water, was returned to its hangar. The left wing root was heavily damaged and the builder probably will not rebuild. The pilot was bruised and shaken up but not seriously hurt.

The cause of the engine failure was traced to the mixture outer cable attach point near the carburetor. This attachment had been perfect for seven years and almost 600 hours but

failed at 600 feet over the bay shortly after take-off. This failure was such that the mixture lever arm on the carburetor was pulled to the idle cut-off position. The pilot was unable to richen the mixture, or even to move the mixture at the carburetor, in spite of his best efforts.

Arthur Schwartz' beautiful VariViggen. This is how it looked before he was forced to land in the Piconic Bay.

What can we learn from this accident? Engine controls are every bit as important and critical to flight safety as flight controls are. Check you engine controls for correct travel and try to imagine what you could do to make sure that no matter what fails, the mixture fails to full rich and the throttle fails to full power. The opposite result is simply unacceptable. A spring that pulls mixture and throttle arms to full rich and full power could prevent such a problem. At least with full power you could use the cockpit mixture lever to regulate power (it works just like a throttle) or even the mag switches to cut power off to facilitate a landing. Using mag switches to regulate power is not as good as using the mixture control. Above all, check that the clamp that secures your throttle outer cable and mixture outer cable are as near perfect as your ability and skill allows. A failure here is not acceptable.

VARIVIGGEN Check engine control cables for secure attachment at the engine as well as at the throttle quadrant. Install springs to guarantee that carburetor controls fail safe.
