# THE CANARD PUSHER

No. 79

Oct. 1994

RUTAN AIRCRAFT FACTORY, INC.

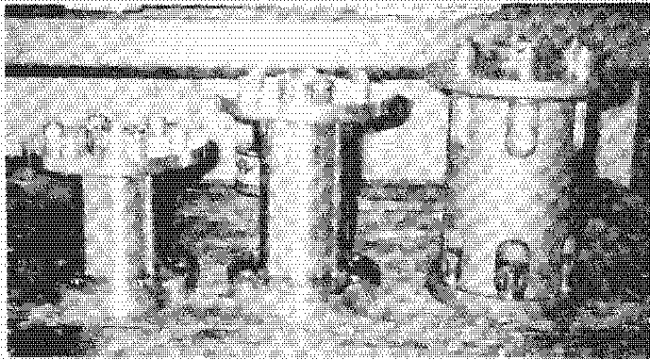
Left to right: Woofter Mfg. prop extensions; 6" long, 8" long, both with 7" dia. prop flanges in bare aluminum. Normally these extensions are black anodized. 9" long Bob Beard/Mike Melvill design has 7" dia. prop flange but the dia. in the middle is 5" as compared to 3-1/2"

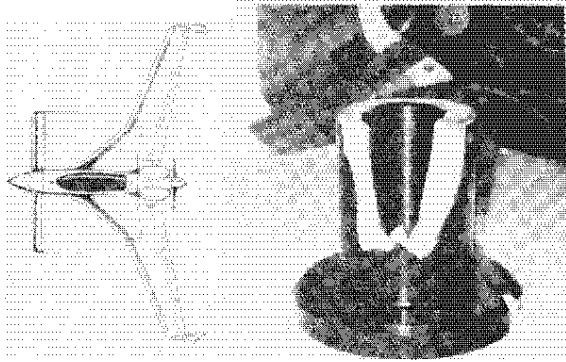
The engine was a Lycoming O-360, 180hp. The prop was a B&T prop and it was driven by a Brock prop extension 6" long with a 7" diameter flange at the prop end. The fracture started right in the radius between the barrel and the aft flange and propagated across the extension. This fracture has been characterized by experts as being a high cycle, fatigue failure. The total time on this prop extension (and on the aircraft) was 72 hours. What caused this failure? Is it something we should be worried about?

The prop extension that did fail had three strikes against it. First of all, the radius between the flange and the barrel of the spool-type prop extension was too small. Other prop extensions we have examined, including several other Brock extensions, have 1/4" radii. The failed extension had only a 3/32" radius (less than half the normal radius). Also, in this radius, there were

machine marks, tool "chatter" marks, in fact. Expert opinion says that chatter marks in a highly stressed part are bad news. These chatter tool marks are longitudinal "ridges" and are torsional stress risers. Also, the forward face of the prop flange was in the same plane as a change of inside diameter and this area had a sharp radius.

None of these features are good news - all of them in one prop extension are probably bad news. Add to that the possibility of a slightly out of balance prop and then throw in the possibility that the engine/prop extension/prop may have been running in resonance causing maximum stress in the aluminum prop extension.

This is the failed prop extension. Failure occurred at the radius where the 7" dia. prop flange intersects with the 3-1/2" dia. barrel.

If you use a 6" long or longer prop extension remove the cowling and spinner and carefully inspect the prop extension using a strong light. Look for machine tool marks (chatter marks) in the two radii or a radius smaller than 1/4" or hairline cracking in the anodized finish in the radii. This is particularly critical if you have a Lycoming O-360 engine. Discovery of any of these flaws is a ground-the-airplane problem. Contact RAF with a detailed description of your problem.

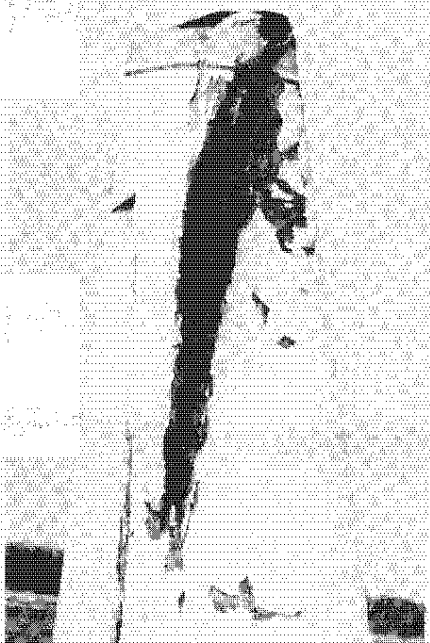
In addition to the above damage, his nav/comm was burned out, a handheld wired into the airplane was destroyed, the voltage regulator, intercom and strobe power supply were burned up, a digital CHT monitor, a digital fuel flow meter and bus voltmeter were destroyed. One co-ax antenna cable was burned. No other wiring was damaged. The lightning entered at the NG-3/NG-4 nose gear brackets, burning a 2" hole in the nose gear fairing, then ran around burning out the various electronic items and, finally, traveling outboard along the antenna co-ax and exiting from the tip of the left winglet. This is what we are told probably happened. Andy Plumber is a lightning expert and Burt has talked to him about this incident.

It is Andy's opinion that this was a very tiny lightning strike! He also informed us that had this strike occurred in flight that damage most probably would have been less, not more! He is absolutely adamant that no unprotected composite

Dan Worley's Long-EZ winglet after suffering a lightning strike while parked nose down on the ramp during a storm.

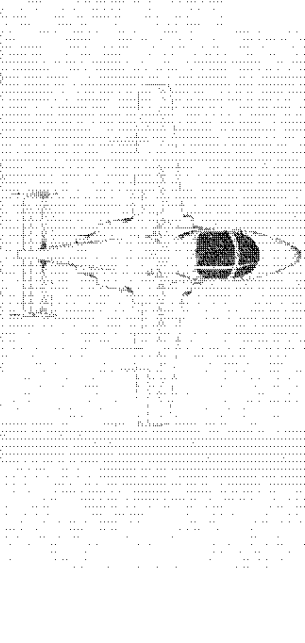
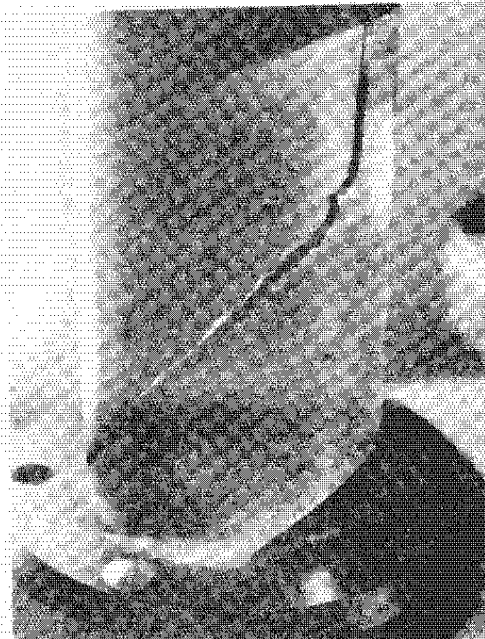
About the same time, Danny Meyer was flight testing his Velocity, also a pusher, when he had almost exactly the same experience Bob Beard had. It turned out that both prop extensions had come from the same source. Both were made from 6061-T6, both were 8" long and both were using Lycoming O-360s.

The difference in strength between 6061-T6 and 2024-T351 is only 18-20% so although the wrong material may have been the cause of this problem, at least on an 8" long prop extension, 18-20% is not much margin of safety.

Bob Beard's original 8" long prop extension made from 6061-T6 aluminum.

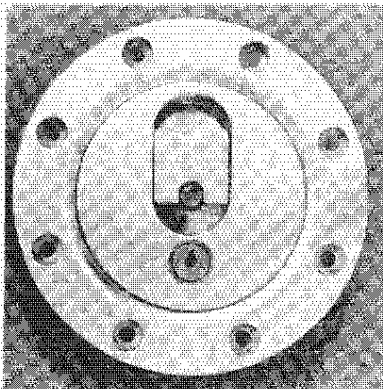
The Newton fuel cap. Solid aluminum anodized and polished - available with or without the locking feature - absolutely seals against fuel leaks with 'O' ring seals

Recently, this problem was solved by installing the second vents in each tank and by removing the drilled fuel caps and installing Newton Aero fuel caps. These are sold by Aircraft Spruce and are made in England by Robin Voice. These are truly works of art! They have been in production for more than 10 years and can be found on a wide range of Ducati motorcycles as well as such supercars as the Ferrari F40 and the Jaguar XJ220. It is also common on many European racing cars and motorcycles.
