CANARD PUSHER

JANUARY 2000

VOL 16, ISSUE 1, NO. 99

Lightning Strike Report

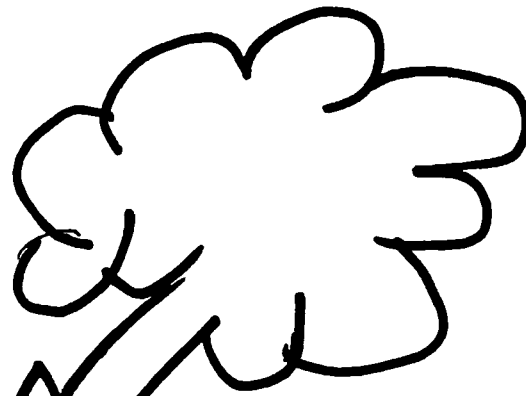
approximately 2,500 feet agl (some 300 feet above the cloudbase), at an estimated 800 yards from the cloud in clear air and flying approximately 80 kts when the glider was struck by lightning.

Large sections of its airframe disintegrated. The instructor later stated his memory was not clear. He remembered hearing a 'very loud bang' and then 'feeling very draughty'; he also believed that he may have momentarily lost consciousness. On recovering, he felt dazed and became slowly aware that 'something was seriously amiss' and that this was 'a real emergency requiring unpleasant and decisive action'. He was able to shout to his student in the front cockpit two or three times to undo his straps and abandon the glider but, owing to some impairment of his hearing, the student was unable to hear him clearly.
