# CANARD PUSHER

JANUARY 2001 RUTAN AIRCRAFT FACTORY VOL 17, ISSUE 1, NO. 103

## MANDATORY Plans Changes

### AILERON CONTROL SYSTEM RODEND SIZE

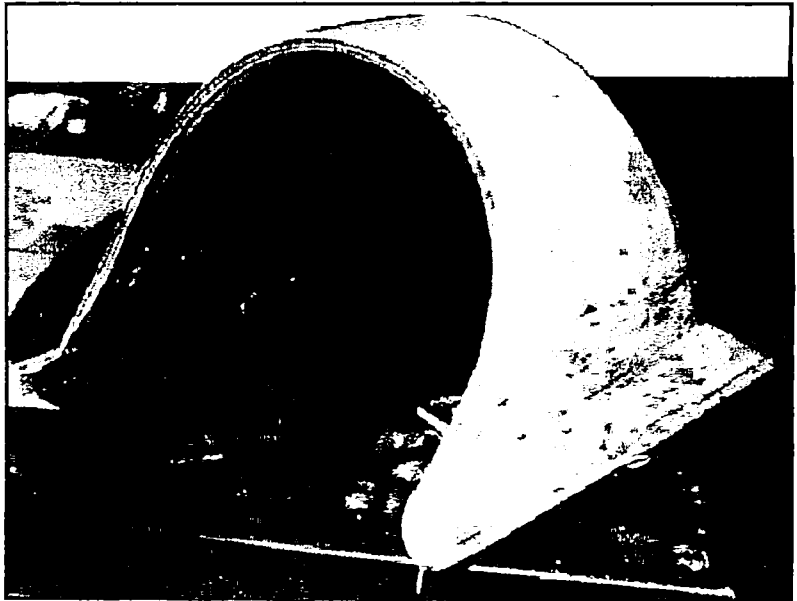
Burt and Mike's basic concept for the composite roll over structure is this: your own finished canopy in its frame is used for a mold, and a glass/foam/glass sandwich structure is laid up into the inside of the canopy (after the canopy is carefully protected and released). There are 6 cure cycles required to complete this part, then it is popped out of the canopy/mold, and finished in whatever color takes your fancy. Then it is bonded into the canopy frame, using Hysol adhesive, where it is positioned between the front seat and the rear cockpit, somewhat like the glass structure that exists between the two canopies on a Berkut. The difference is that this one is inside the canopy.

There is a small gap between the roll over structure and the Plexiglas canopy, so it never touches your canopy at all. It becomes part of the canopy itself, and moves with the canopy when you open and close it. When the canopy is closed and latched, the roll over structure is firmly attached to the top longerons, and is designed to protect against an accident where the airplane may land in such a way as to end up upside down.

The down side is that there is some loss of the fabulous visibility that we have all come to enjoy in an EZ, but it is a small price to pay for the additional safety provided. See Photo. ●
