# CANARD<sub>P</sub>PUSHER

VOL 28 ISSUE 3 NO. 109

## IMPORTANT STRUCTURAL NOTICE

# VARIEZE WING SPAR & WING ATTACH STRUCTURE

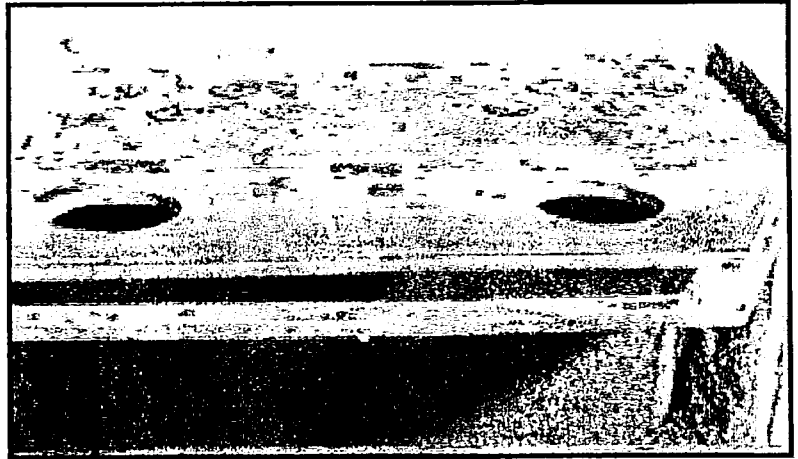
**Such severe corrosion in this wing attach fitting, in a VariEze that has been flying for 20 years means that it is possible that many other VariEzes out there could also be affected.**

This VariEze was built before the recommendation came out to Alodine all aluminum parts. For some reason not understood, only the right upper wing fitting was affected by this corrosion. The lower right, and both upper and lower left wing attach fittings on the center section spar are essentially corrosion free. In this case the owner had installed cover plates over the normally visible, wing attach aluminum plates. These consisted of thin aluminum covers that were fitted over the wing fittings, and held in place using silicone as an adhesive. This made it impossible to inspect the actual WA-2 wing attach plates during a normal pre-flight walk around. Had it been possible to easily look at the top surface of the WA-2 plates, there were indeed indications of corrosion at the inboard edges of this WA-2 plate that should have been noted during a pre-flight inspection.
