THE CANARD PUSHER

No. 47

January 1986

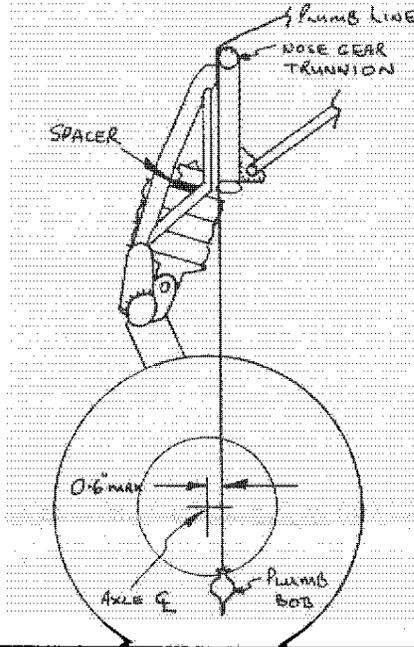
The Defiant nose gear is a Mooney nose gear unit. Mooney has put out a service bulletin (M20-202) which speaks of steering/tracking improvements. We have essentially reiterated that bulletin below.

- 1) Level the aircraft and center the nose wheel.
- 2) Hang a plumb line over and forward of the nose gear trunion (see sketch).
- 3) Measure forward from the aft edge of the plumb line to the axle centerline. This distance should not exceed 0.6", or be less than zero.
- 4) If you have more than 0.6" or less than zero, you will have to add or subtract spacers above the suspension donuts (see sketch), until your axle centerline is within this tolerance.

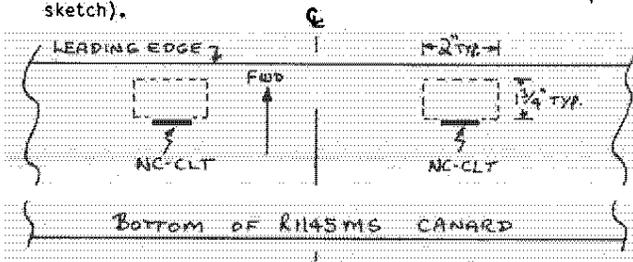
Ken Brock has mailed out registered letters to all known purchasers of part #NC-CLT warning of the incorrect material and offering to replace them with the correct material. Do not ignore this situation, even if you have installed them and are ready to fly, ground the airplane until they have been removed and replaced.

This is really not such a traumatic job as it appears! We have done it ourselves several times. Using a Dremel saw, carefully cut through the bottom skin in front of each lift tab (don't try to cut through the spar cap!!). Remove a skin patch approximately 2" wide by 1 3/4" forward of and centered about each lift tab. (See sketch).

Now dig out enough foam to be able to see the heads of the three AN-4 bolts that anchor the NC-CLT lift tabs to the shear web. Using a dull chisel or even a screw driver and a small hammer, chip away enough micro so that you can fit a 7/16" box-end wrench on each bolt head. Remove these bolts and give the lift tabs a sharp tap forward and they will pop off. Send them back to Brock in exchange for the "real" ones. Sand the aft face of the new lift tabs with 320 grit and sand the face of the shear web. Smear a thin layer of flox onto the shear web and re-install the three AN-4 bolts. Carve a block of blue foam to fit as closely as possible into each of the holes and micro them into place. (Pour-in-place X-40 can also be used). Sand the foam to match the bottom contour, and carefully sand the bottom skin completely dull a minimum of 3" each side of each hole and about 1" forward of each hole. Layup 3 plies of UNO spanwise. Across the repair area, the largest ply goes on first. Since most, if not all of this repair is inside the fuselage very little fairing is necessary. Do not be intimidated by this repair, it is quite easy and can be done in a surprisingly short time.

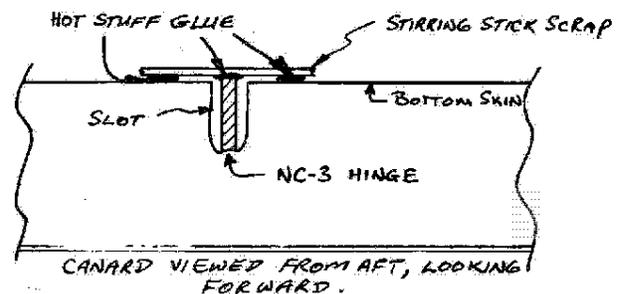
Several builders have reported not being able to get the full 15° of elevator trailing edge up travel. This is very important to assure adequate nose down authority at aft limit CG. The best way to assure that this does not happen to you is to follow the plans as far as jiggling the elevators into position with the NC-3 hinges inserted into the slots in the canard. Do not pour in the wet flox yet! Using scraps of wood stirring sticks (tongue depressors) and Hot Stuff glue, temporarily tack each NC-3 to the canard bottom skin as shown.

Use Hot Shot to kick the Hot Stuff off. (If you don't have a bottle of the thick Hot Stuff and Hot Shot, you really are missing a very handy jiggling tool). You should now have the NC-3 elevator hinges temporarily bonded into position, with the elevators mounted to

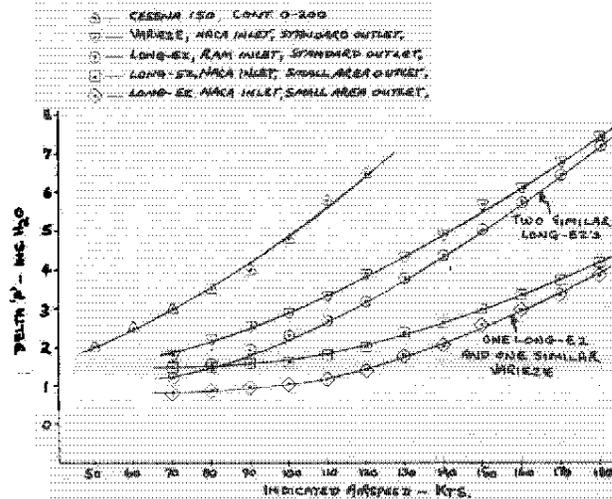
Lycoming says that for a Lycoming O-235 engine, you need a delta 'p' of about 4" of water. The curves shown below are the results of our recent tests.

Note that the two Long-EZs with the lowest delta 'p' across the cylinders (only 3" delta 'p' at 160), do in fact, have good cooling. Both are well equipped with 4 probe calibrated CHT gauges. What does this prove? Only that if the baffling is excellent, tight with absolutely no leaks, the cylinders will cool acceptably even with only 3" of water delta 'p', also, note that both of these Longs have smaller than normal cooling air outlets.

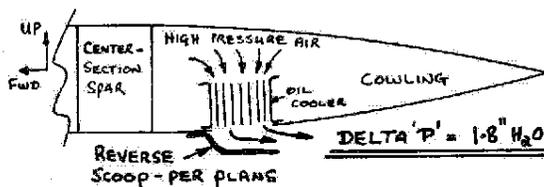
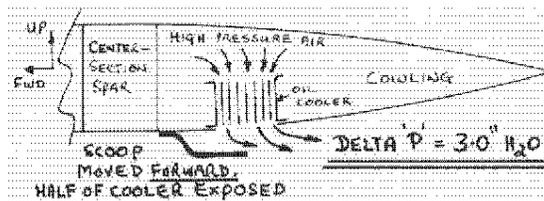
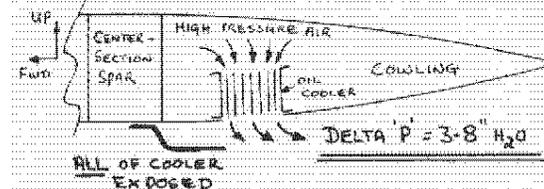
OIL TEMPERATURE PROBLEMS

Dick Rutan has been doing a lot of cooling related testing on the Voyager and during his test for optimum oil cooling, he discovered an interesting method to improve cooling air flow through an oil cooler. Using the Voyager water manometer, Dick found that with an oil cooler mounted on the inside of a cowling, such as a Long-EZ does, where the cooler is in the high pressure plenum of the cowl, and vented to the free stream, the following delta 'P' measurements were true.

With NO reverse scoop over the oil cooler (you can see the cooler from outside) the pressure differential was 1.8" of water. He installed a reverse scoop per plans, still 1.8" of water delta 'P'. He moved the reverse scoop forward, exposing half of the oil cooler - 3"H₂O delta 'P'. A dramatic improvement to say the least. Next he moved it forward enough to expose the whole of the oil cooler - 3.8" H₂O Delta 'P', and much cooler oil temperatures. If you are having oil temperature problems in your EZ, try this neat trick
