# THE CANARD PUSHER

No. 68

July, 1991

**PLANS CHANGES AND OTHER IMPORTANT MAINTENANCE INFORMATION**

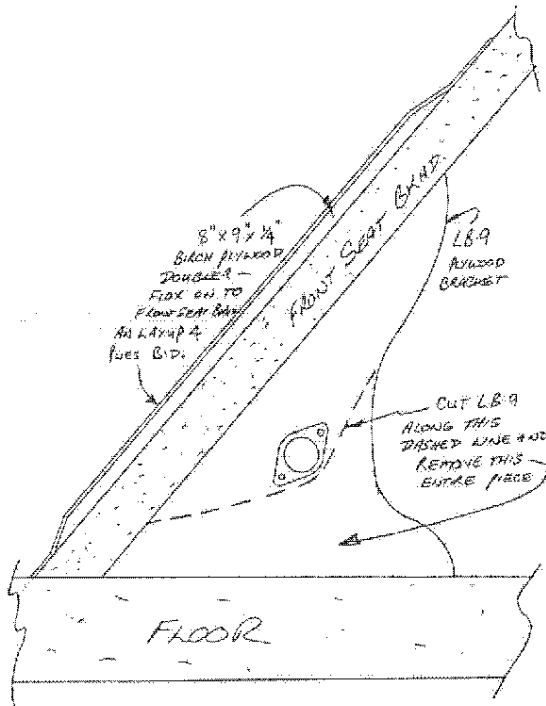
A Long-EZ was involved in an accident in Utah recently that resulted in serious back injury to the pilot who was flying solo. This pilot was a relatively new private pilot with only a few hours in type. While attempting to cut a roll of toilet paper, this pilot managed to get the airplane too slow, with too much angle of attack and the airplane apparently entered a "deep stall" condition. The pilot did not recover from the deep stall condition, and the aircraft descended in a flat attitude (75 to 85 degrees AOA), striking the ground slightly nose high with very little forward speed. The pilot suffered serious back injuries and the entire aircraft bottom and landing gear were heavily damaged.

There were a number of eye witnesses to this accident and our investigation leads us to suspect that the aircraft was being flown with a CG that was well aft of the published aft limit. This aircraft also was not equipped with vortilons.

This particular accident and injury pointed again to the advisability to modify the LB-9 plywood

bracket that supports the landing brake actuating weldment. This was called out as a mandatory change in July 1981, CP29, page 7. We have noted that few builders have made this modification. We would like to reiterate this requirement and add an additional change as shown in the sketch below. Cut away the entire lower portion of the LB-9 bracket as shown and remove the lower piece and discard it. Cut out a piece of 1/4" thick birch plywood (firewall material) approximately 8" wide and 9" long. Bevel the edges and flox it onto the forward face of the front seat bulkhead, centering it over the LB-9 bracket. Lay up four (4) plies of glass BID over the entire piece of plywood lapping onto the front seat bulkhead a minimum of 2" all around.

MODIFY THE LB-9 BRACKET AND INSTALL A 1/4" BIRCH PLYWOOD DOUBLER PER THE DESCRIPTION ON PAGE 8 OF THIS NEWSLETTER ALSO, A MANDATORY WEIGHT AND BALANCE MUST BE DONE. NOTE: VORTILONS ARE MANDATORY ON THESE 3 AIRCRAFT.

This change is mandatory and should be completed before next flight. Also, strongly consider the use of the energy-absorbing Tempa-foam cushions for both seats. Now, this may seem ridiculous to modify your airplane in order to protect yourself from a full-blown deep stall crash that on a normal airplane would be fatal. However, we continue to be surprised at the protection provided by the EZs composite structure and we always take the conservative approach to increase safety as much as possible.
