CANARD PUSHER

OCTOBER 1996

RUTAN AIRCRAFT FACTORY

VOL.11, ISSUE 4, NO. 86

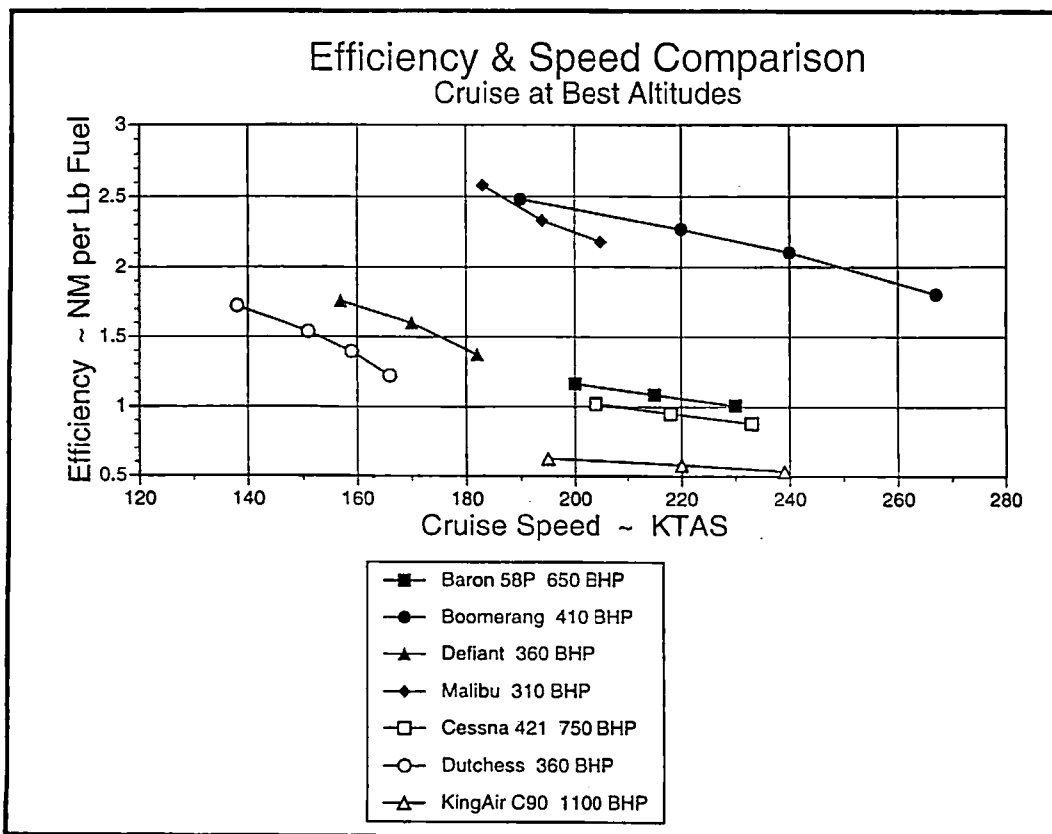
Figure 2

and-a-half of fuel remaining. (see figure 2 for a comparison of the Boom's efficiency and speed to other light aircraft).

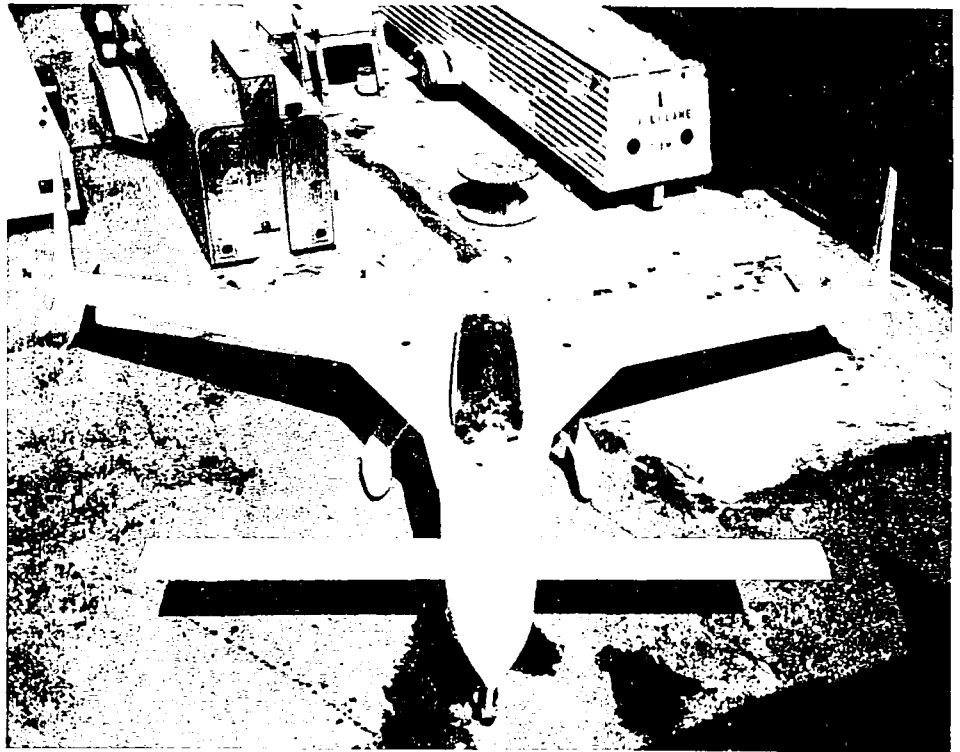
A Long-EZ pilot has reported finding moderate to severe corrosion in the elevator hinge brackets on his GU canard. He did not build this airplane, and the history of this airplane is not known, but it currently is based on the East Coast in a salt water environment and the corrosion was significant enough to cause this pilot to dig out all of the hinge brackets and replace them.

We have not found anything like this on any of our aircraft, but keep in mind all of the EZ types here in Mojave live in hangars and in a dry desert environment. We will continue to investigate this problem, and will report in future CPs. Every EZ and Defiant owner should make frequent careful inspections of these hinge brackets. Keep in mind that there was little or no evidence visible outside the canard. The corrosion took place inside the canard, where the bracket was floxed into place in the high density foam insert. Probably moisture was "wicked" up into the flox/high density foam and was trapped in close proximity to the 2024-T3 aluminum brackets.

What can be done to prevent such an occurrence? The best thing to do for these brackets, and all other aluminum parts, is to treat the bare aluminum with Alodine 1201, after pre-cleaning with Alumiprep 33, *prior* to installation. They should then be sealed in pure epoxy prior to bonding them into the canard. We plan to do surgery on Burt's Defiant canard, which was built in 1978, and we will report on the findings in CP 87.

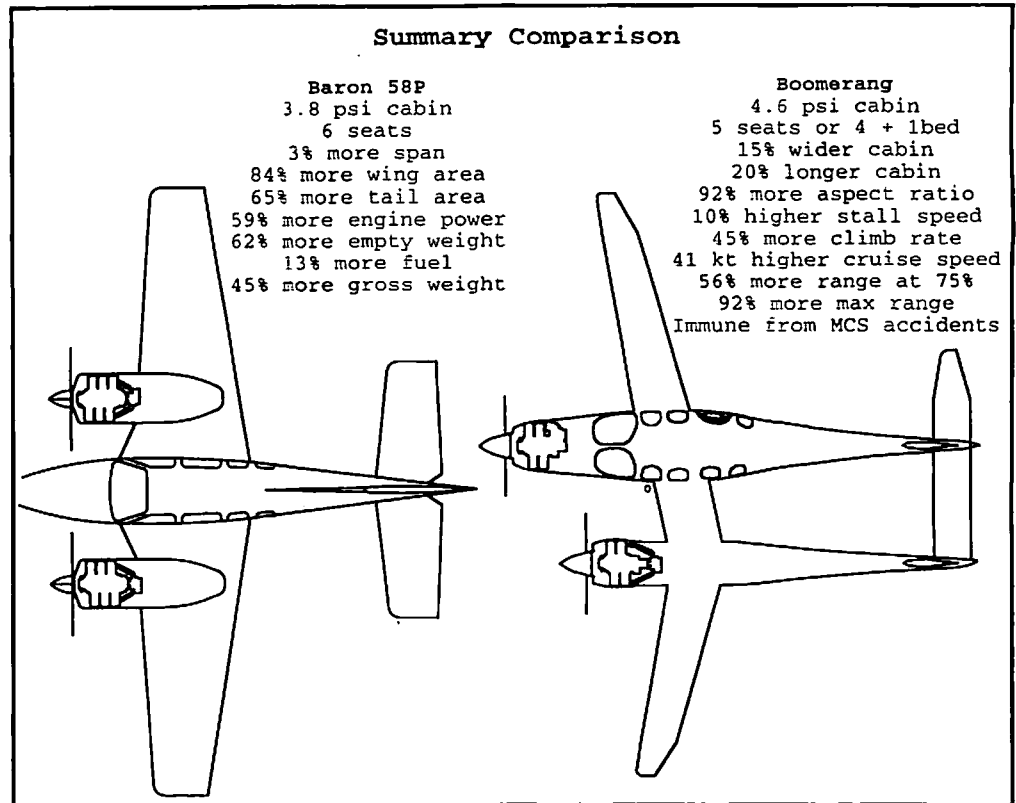
Figure 3

During the SETP talk, Burt presented the design rationale by showing that by making incremental improvements to a pressurized Barron the aircraft a designer could arrive at the Boomerang configuration. Space does not permit the Canard Pusher to publish that rationale, however the adjacent summary comparison shows the dramatic differences.

Note that the Boomerang has less powerful engines than a pressurized Barron, but considerably more speed, range and safety from minimum single engine controllable airspeed type accidents.

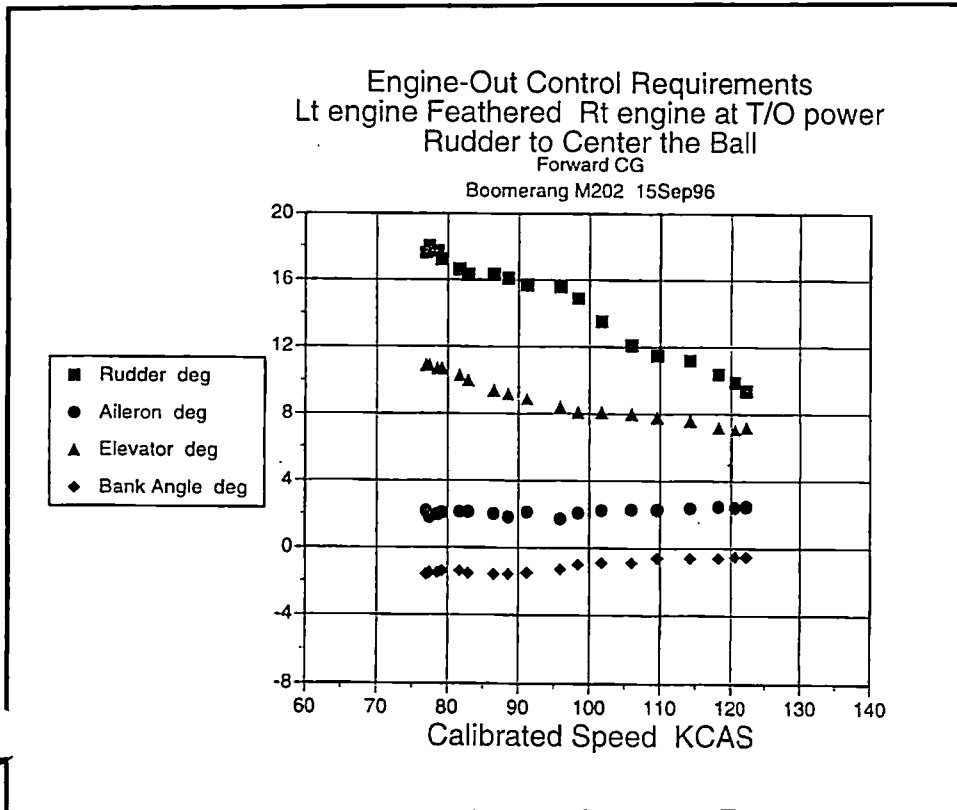
Figure 4

Figures 4 - 7 illustrate the complete data for the Boomerang when flown with one engine inoperative. Note that if the pilot centers the ball, more than twice as much rudder is required to handle an engine-out if the left engine is failed than to handle an engine-out if the right engine is failed. This appears backwards since the Boomerang's left engine is at butline -56 and the right engine is at butline only +32. The reason for this is primarily the P-effect which causes a thrustline of engines to move to the right as angle-of-attack increases. Thus, even though the Boomerang looks geometrically asymmetric, it is not geometrically asymmetric enough in order to make its engine-out control symmetric. In other words, to make the airplane symmetric at minimum speed you would have to move the left engine even further from the fuselage.

Actually this is all academic since the airplane can be controlled quite easily at its minimum speed with a margin of rudder remaining.

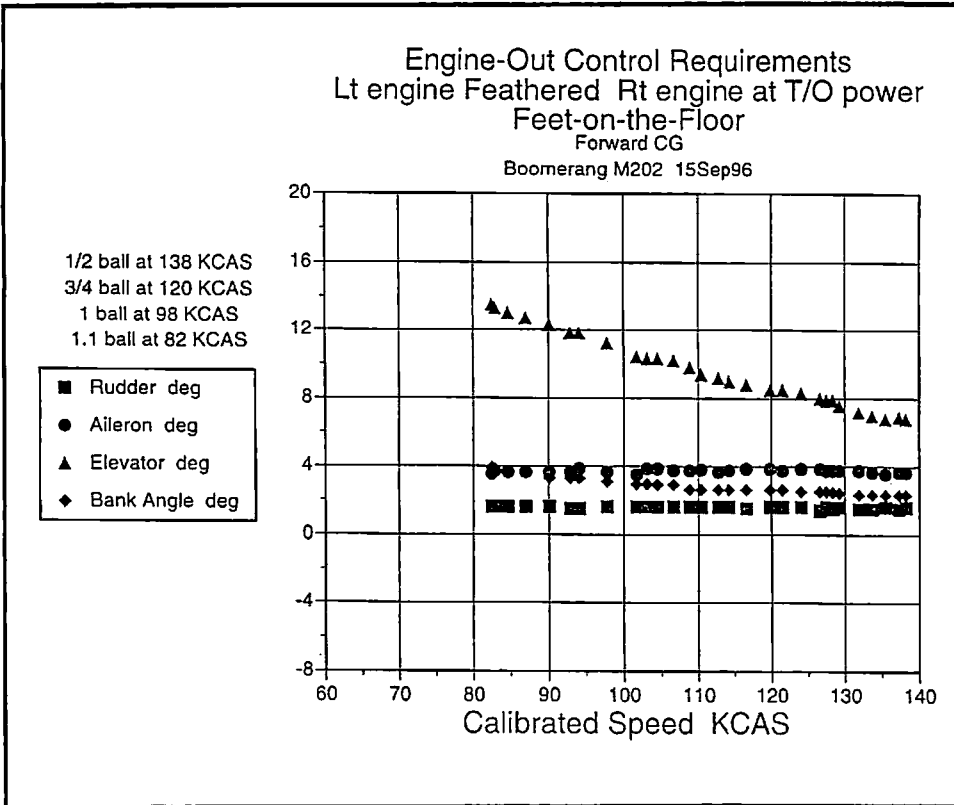
Figure 5

The most interesting data, though, are figures 5, and 7, showing the control authority needed to handle engine-out if the pilot merely places his feet on the floor rather than tries to center the ball. Surprisingly, very little aileron is required. Boomerang handles engine-out very nicely down to minimum speed with no rudder at all!

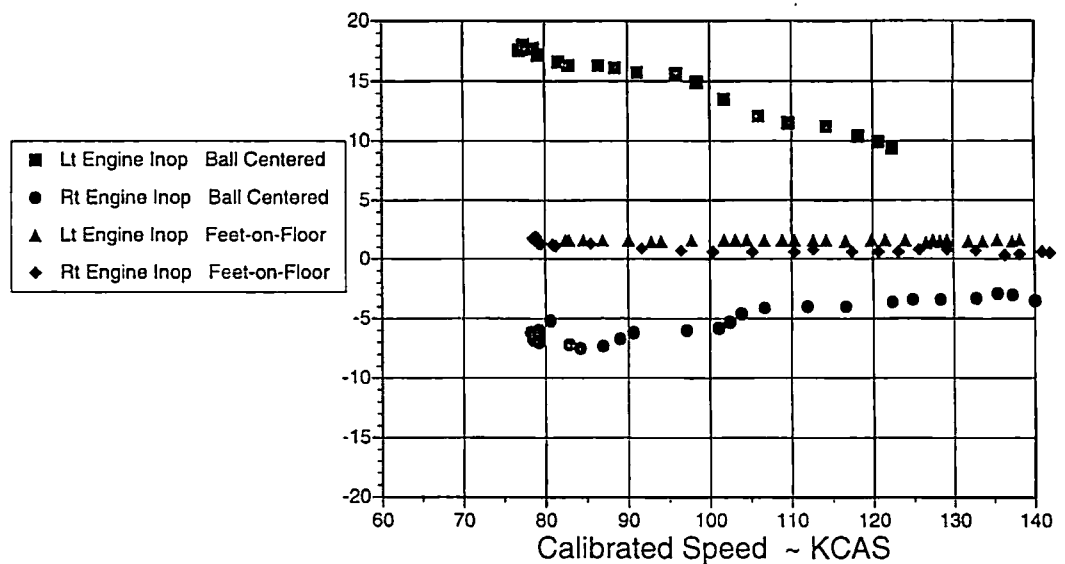
Figure 8 summarizes the rudder requirements for all four maneuvers.

Engine-Out Rudder Requirements
 Boomerang M202 15Sep96 fit

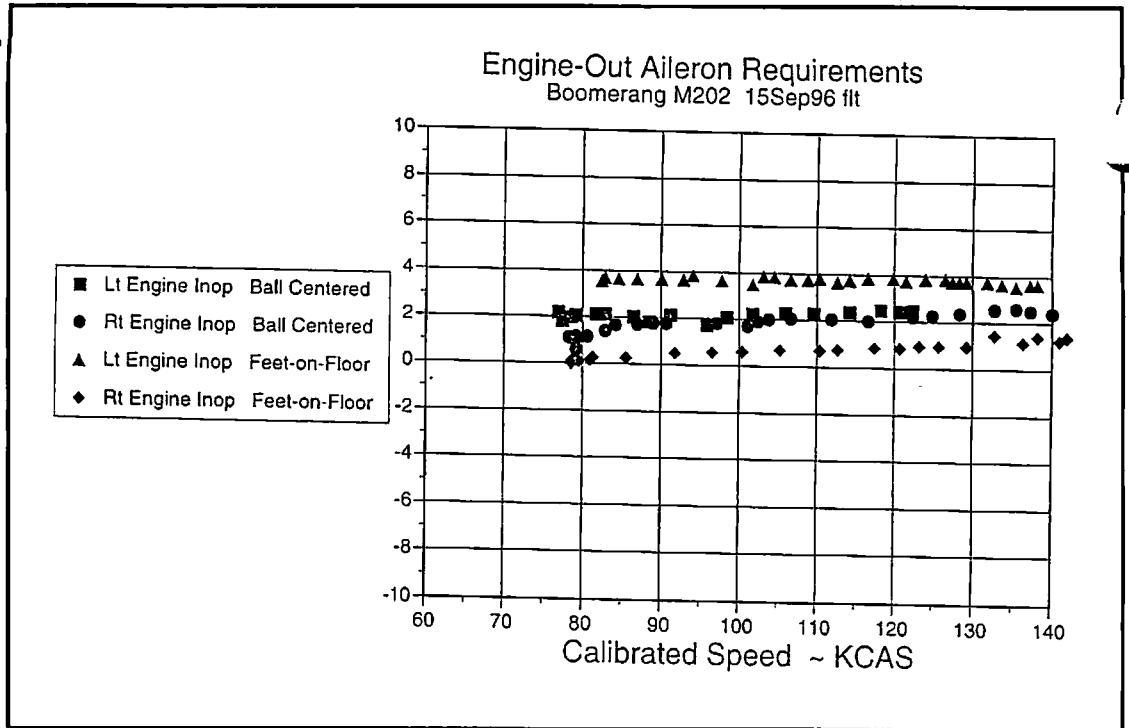
Figure 9 summarizes the aileron requirements for all four maneuvers. Note that if the pilot does nothing with the rudder pedals and lets the rudders float near zero, only about two degrees of aileron are required to maintain course. This was a surprising result and in order to determine how unusual this characteristic is, Mike and Burt went out and did engine-out testing with a Beechcraft Duchess, one of the safest light twins for engine-out flight. The results of the Duchess and the Boomerang are presented on figure 10. Note that if the Duchess pilot uses a normal technique of 5 degrees bank into the operating engine and the Boomerang pilot tries to center the ball, there's not a tremendous difference in the rudder requirements. The Duchess has its min-control speed about 12 percent above stall, and the Boomerang has some rudder remaining at stall. However, if both airplanes are flown with the feet on the floor, with the critical engine failed,

there's a dramatic difference. The Duchess ends up at 22 percent above stall speed with full aileron into the operating engine and a large bank angle. The Boomerang, on the other hand, can be slowed to stall speed using only a modest proportion of the available aileron and very little bank.

This dramatic difference is not entirely due to the Boomerang's unusual configuration. It's mainly a result of having ample directional stability and low dihedral effect. Thus the ample directional stability handles the engine asymmetry without application of rudder, resulting in a small side-slip angle. And because the dihedral effect is low, a small amount of aileron is required to trim that resultant side-slip angle.
