Load test to failure of VariEze N11EJ

Our thanks to Ernie Joiner, who donated his Varieze so that we might all benefit from a structural load test-to-failure of this 21-year-old airplane.

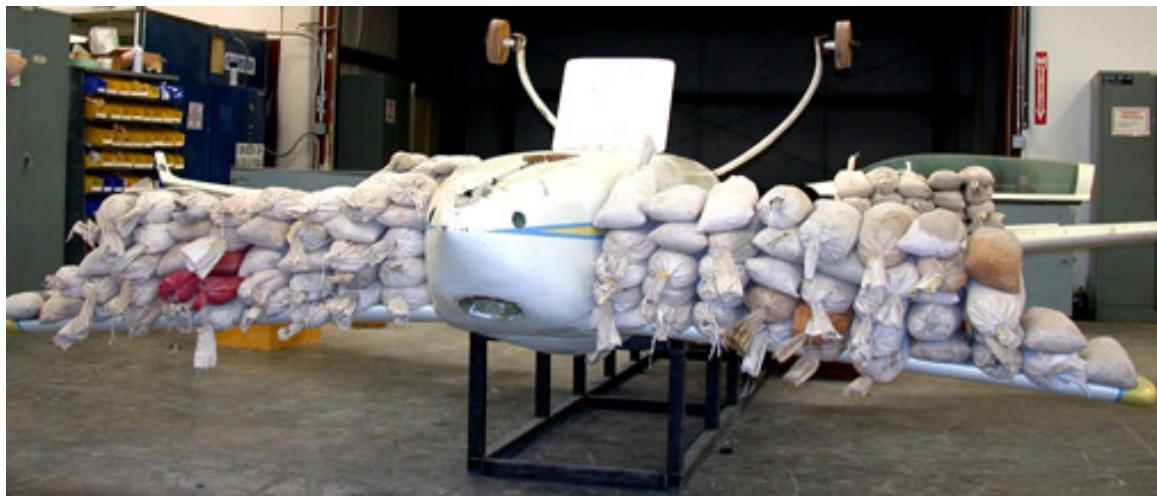
The canard shown here prior to adding another row on top of the first 8 stacks on each side. We missed getting a photo fully loaded due to an early failure! It failed at 8.3 'Gs'

We decided to load the canard first, but in order to do that we had to stack a bunch of shot bags on each wing root, to prevent the whole plane from nosing over! As you can see from the enclosed photos, we stacked 6 shot bags vertically starting at the side of the fuselage, and working outboard. We ended up with 8 vertical stacks of six 25 lb. shot bags, one stack of two shot-bags, and finally just one shot-bag at each canard tip. After a few seconds, the canard failed symmetrically starting at the right root, but both sides broke flush with the sides of the fuselage. Based on the maximum gross weight of a VariEze of 1050 lbs., this particular canard failed at an 8.3 'G' load factor.

This is lower than we expected. We have failed several canards over the years, none as old as this one, so age may be playing a part here, and we who fly these types of aircraft, should bear this fact in mind! The symmetrical failure and the failure mode were unusual though, and had not been seen before. The top spar cap, loaded in compression, popped loose from the 'C' shaped shear web lay-up beneath it, tearing the top skin loose, and then the shear web and lower spar cap failed catastrophically on both sides at almost the same instant. Typically we have seen one side of the canard fail all at once, at a load factor of 12 'G's, or more. We have never seen the top spar cap separate at the secondary bond line between the shear web and the top cap. This may have been due simply to the age of the materials and/or the hot/wet semi-marine type environment in which this aircraft spent most of its 21 years of life. It could also possibly be a workmanship issue, an incorrectly prepared shear web surface for example, or a combination of both.

Conclusion: Based on just this one test-to-failure of what appears to be a well-built VariEze, we must insist that all Varieze flyers, as well as Long-EZ flyers with GU canards, should never exceed 3.5 'G' in flight. If you do, particularly at heavier gross weights, you are possibly in danger of an in-flight structural failure! Do not take this lightly!

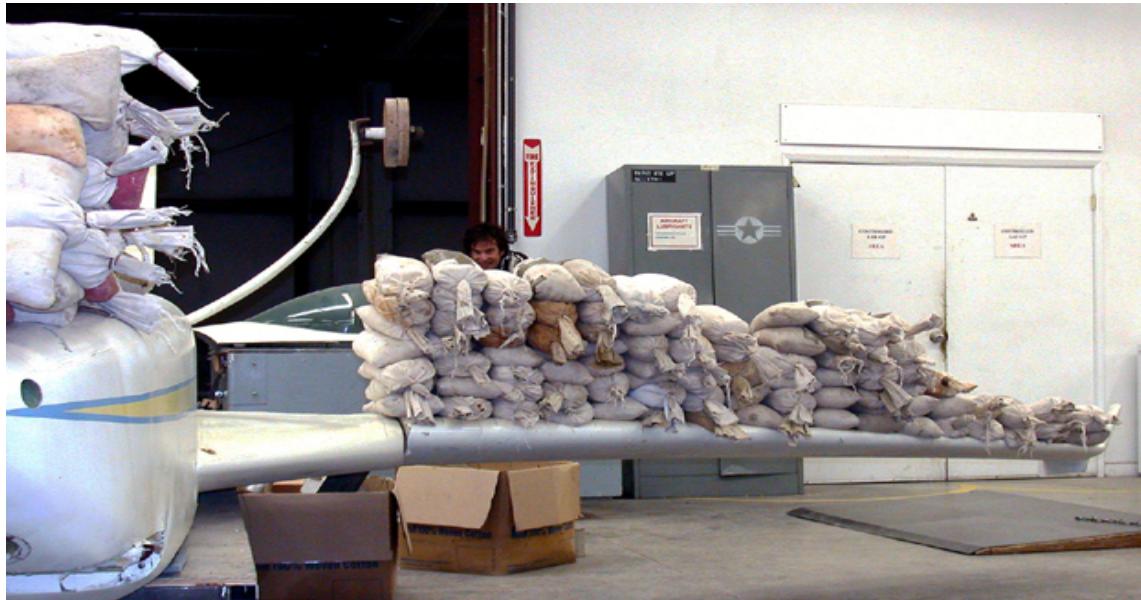
The left wing shown one instant before it failed catastrophically at 7 'Gs' Note the leading edge of the wing mismatched with the fuel strake as it fails!

The main wing was then carefully loaded, see photo. Because the normal failure of a VariEze wing would almost certainly be near the end of the wing spar box, around mid-span of the wing itself, we deliberately loaded this set of wings biased to the inboard to ensure a failure at or very near the wing fitting itself. In this we were successful. The failure occurred right at the wing attach fitting in the centersection spar. Just prior to this failure, the additional torsion that was applied, due to our desired load schedule, caused the centersection spar to tear away from the lower fuel tank skin, then the centersection spar box failed cleanly at the inboard edge of the wing fitting. The load factor at the moment of failure was 7 'G's. This failure also occurred at a lower load than expected. Some of this was due to our desire to fail the wing at the wing fitting. Some of it may be due to old age, and the hot/wet semi-marine environment in which it was stored. It is difficult to quantify exactly why the wings and the canard on this particular aircraft failed at a lower than expected 'G' load factor.

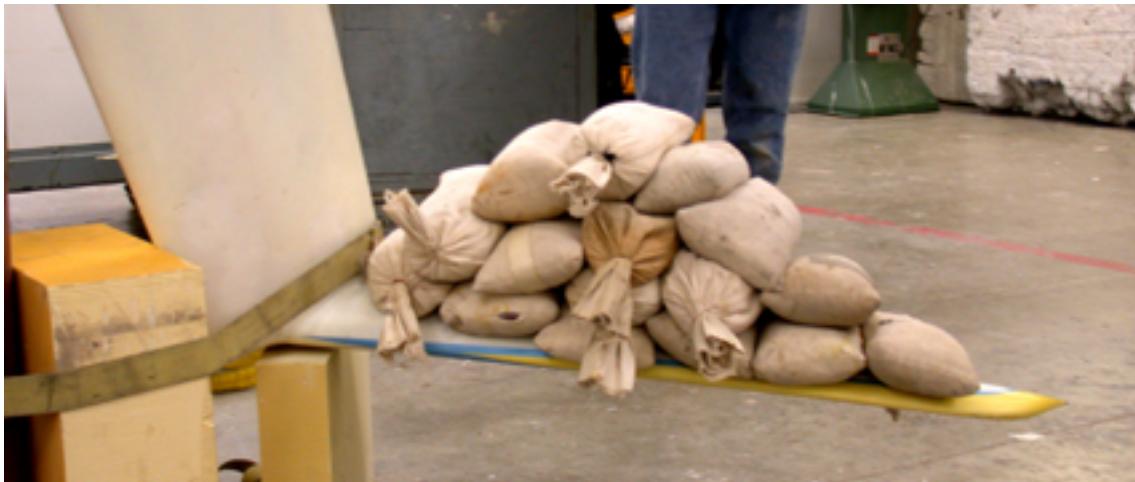
Prior to conducting this structural load test, we had done an informal load test to failure of the winglet to wing joint. We stood the left wing on its root end, and secured it to a structural steel post. We loaded this winglet such that the loads were bending the tip of the winglet inboard, because in normal flight, the lift generated by each winglet bends the winglet tip inboard, (toward the engine). In an extreme sideslip departure mode however, one winglet might see about one third of this load exerted bending the winglet tip outboard. For this reason we loaded the right wing/winglet so the winglet tip bent outboard.

The wingtip is supported at the winglet root, and the shot-bags shown here represent design limit load. The winglet failed right at ultimate load.

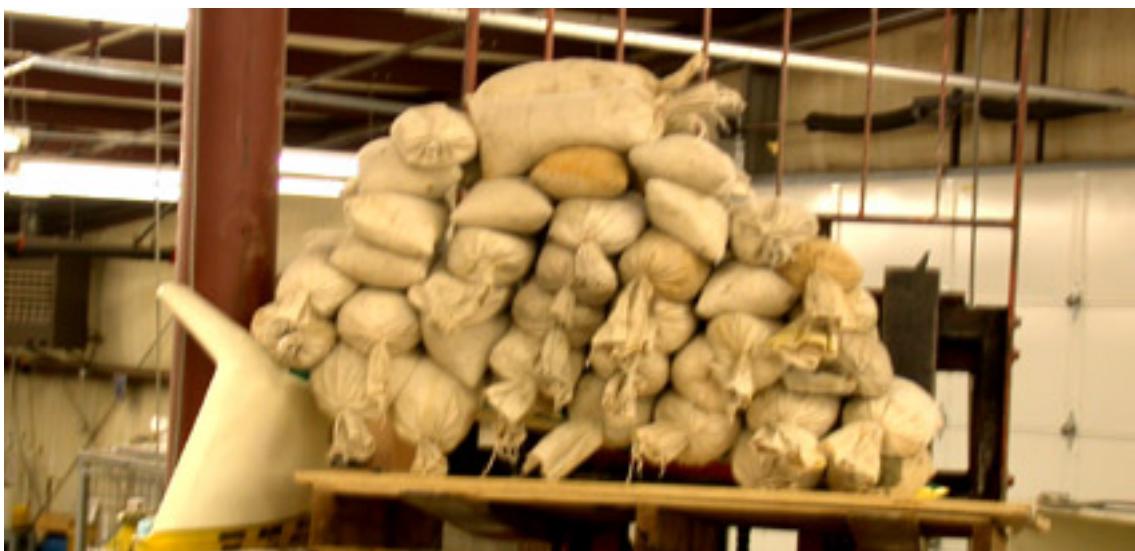
The steel support post & top of the wing can be seen. There are 42 shot-bags on the outboard side of the winglet, and a forklift with a pallet on its forks, is positioned just under, but not touching in case of a failure. It did NOT fail, although this load was more than two times the required strength!

The winglet tip-to-outboard test on the right wing resulted in a failure right at the prediction for such a failure. When we tested the left wing, we ultimately loaded 42 shot bags onto this winglet! This was all that it was possible to physically fit on to the winglet, however, we heard no noise, and could not fail this wing/winglet joint. Indeed, it way exceeded our expectations! Does this mean that age may not play much of a part? If so, maybe workmanship perhaps plays a much larger part?
