05 February 2007

A05W0148

Reference: Aviation Accident
VariEze N914VE
Lethbridge Airport, Alberta
20 July 2005

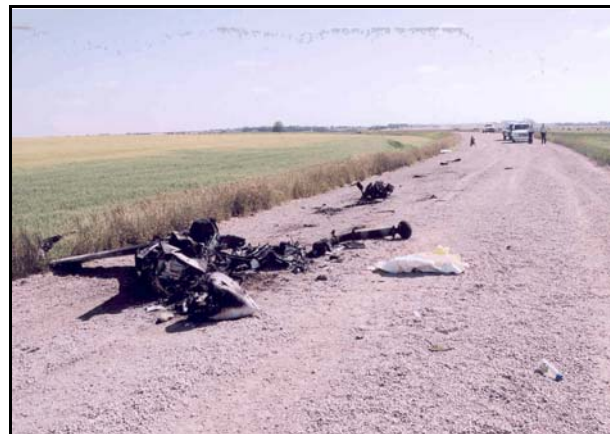
Figure 3: Wreckage trail

The aircraft nosed over after touchdown, struck the shoulder of the road, bounced, and came to rest inverted (see Figure 3). There was an explosion at impact and the aircraft was destroyed by an intense post-impact fire. The accident occurred at 1536, and the accident site was located approximately five-eighths of a mile to the northwest of the threshold of runway 12. The fatally injured pilot was found in the front cockpit of the aircraft. A latched lap-belt was found in the wreckage. Initial information from Alberta Medical Examiner's office indicated the cause of death was the thermal effects of fire.

Examination of the aircraft, the occurrence site, and the wreckage trail showed that the aircraft struck the field on a heading of 214° Magnetic (M). The aircraft had struck a fence post prior to impact. A swath through the 24 to 30-inch-high grain crop indicated the aircraft touched down in a wings and nose level attitude. The nose gear was in the retracted position at impact. The left wing detached when the aircraft struck the shoulder of the road, which may have resulted in fuel being released from the left wing fuel tank. The inboard section of the left wing and the left side of the fuselage sustained extreme post-impact fire damage.

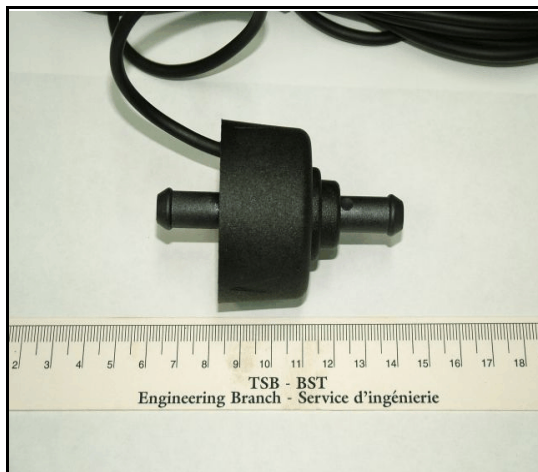
Figure 4: Exemplar NAVMAN Fuel Flow Transducer

A piece of detached, heat-damaged tubing, complete with clamp and remnants of a burned rubber hose, was recovered from the wreckage trail and submitted to the TSB Engineering Branch to determine if it was from the fuel pressure regulator, one of the carburetors or another component in the fuel system. Examination of the fracture surface of the fitting did not identify any signs of a progressive failure. Visual and dimensional comparison of the fitting indicated it was the inlet post of a NAVMAN fuel flow transducer (see figures 4 and 5).

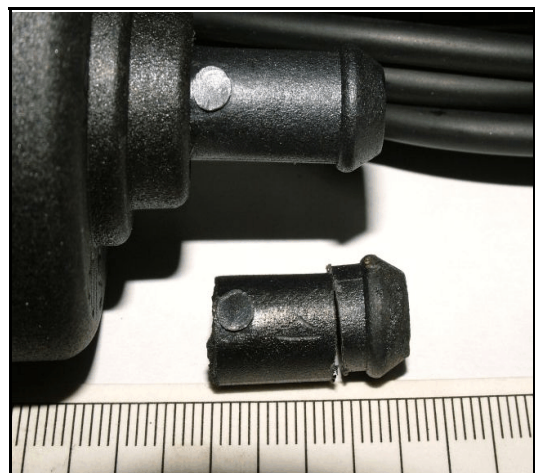
Figure 5: Recovered Inlet Post of Fuel Flow Transducer compared to Exemplar

Since only this small part of the fuel flow transducer was recovered, it could not be determined where it had been mounted in the aircraft, or if it was clearly a factor in the in-flight fire. The NAVMAN installation instructions state that the fuel flow transducer must be installed after the main fuel filter. In this aircraft, the main fuel filter was mounted on the forward side of the firewall, immediately adjacent to where the main fuel line entered the engine compartment, and installing the transducer after the main fuel filter would have placed it in the engine compartment. As well, flow transducers used in aviation applications are usually mounted in the engine compartment. The transducer has a published maximum operating temperature of 50°C and a component failure temperature of 509°C. The transducer, including the outer casing, is manufactured from a composite glass FORTRON material. Fuel flow transducers used in aircraft applications normally have housings made of stainless steel. The engine compartment would see temperatures of several hundred degrees Celsius during normal operation, and if the fuel flow transducer was mounted in the engine compartment it could have been exposed to temperatures that exceeded its maximum designed environmental temperature range.
