622-A050024-1  
825-A05W0148

14 December 2005

**Re: AVIATION SAFETY INFORMATION LETTER A050024-1 (A05W0148)  
Use of Non-aircraft Parts in Critical Systems in Amateur Built Aircraft**

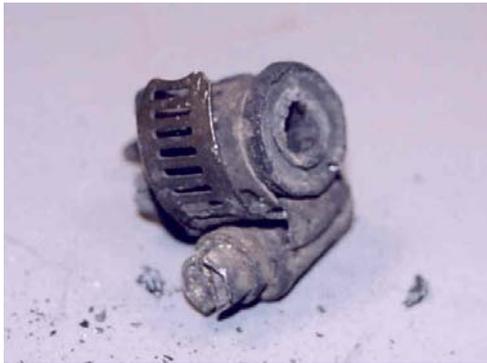
A piece of detached, heat-damaged tubing, complete with clamp and remnants of a burned rubber hose, was recovered from an unburned area of the wreckage trail. The tubing was submitted to the TSB Engineering Branch to determine if it was a fuel system component (see Figure 1) and the mode of failure. Examination of the fracture surface of the fitting did not identify any signs of a progressive failure; however, the fracture surface displayed fire damage. As the tubing, clamp, and hose were recovered from an area of the wreckage trail that was not exposed to the post-impact fire, the fire damage likely occurred prior to impact (see Figure 2).

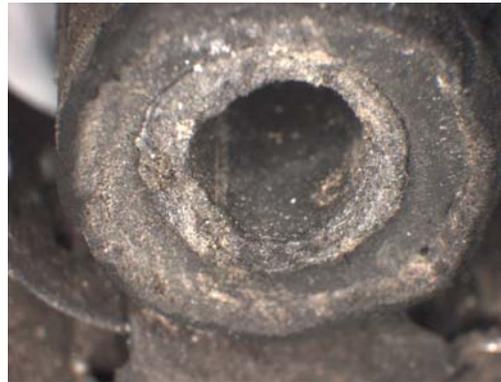
Visual and dimensional comparison of the tube fragment indicated it was the inlet post of a NAVMAN fuel flow transducer (see Figures 3 and 4). Information provided by NAVMAN revealed the fuel flow transducer was designed for marine applications, and not for use in aircraft. At present there is no FAA or Transport Canada (TC) regulation that precludes the installation of non-aviation parts in critical systems in amateur built aircraft.
