N656TE Crash Investigation Report

April 17th, 2025

Abstract:

Lochie Ferrier's family gave Israel Briggs and Marc J. Zeitlin permission to examine the wreckage of COZY MKIV N656TE at a hangar at the Half Moon Bay Airport (KHAF) on March 10th and 11th, 2025. Israel Briggs conducted an additional site visit on April 6th, 2025 to collect several ignition components for off-site inspection and analysis.

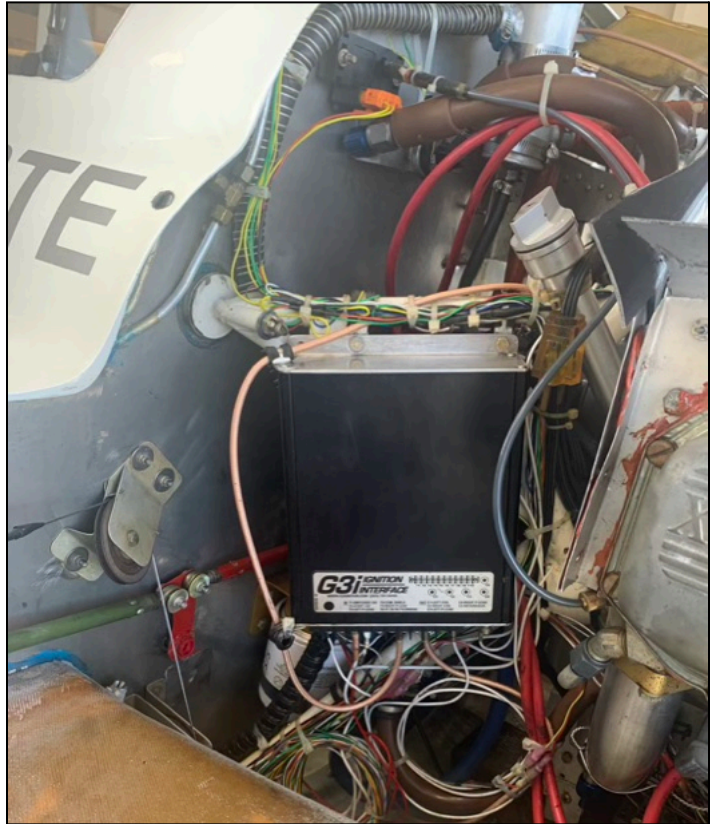
Figure 1:

However, in addition to the two magnetos, **this** aircraft was equipped with an aftermarket G3i Series-2 electronic ignition system, which interfaces into both the left and right magnetos. The manufacturer's marketing literature claims that the unit enhances the magneto's performance by synchronizing the sparks, resulting in better fuel burn and easier starting.

G3i Ignition System as installed, December, 2023

However, there are caveats here with respect to the G3i system, which are that certain failures of the G3i ignition system exist that **can and may** cause spark stoppage from both magnetos. If the G3i system fails internally but is still supplied power, this **will** cause a complete ignition failure. Remediation of this failure (and reversion to normal “magneto” mode) requires the pilot to actively turn off the system to revert the ignition system back to normal "magneto only" mode. The aircraft builder indicated that he told the pilot that in the case of an ignition system failure, turning off the G3i would be appropriate to revert to normal magneto operations, but that there was no “emergency procedure” checklist to use.

Along with a possible internal failure of the G3i system causing an engine stoppage, the G3i uses the **left magneto points only** as the "trigger" for firing **all** the spark plugs - there is no trigger redundancy. If the left magneto points began to fail, all eight spark plugs could have begun to fire intermittently and only turning the G3i system "**OFF**" would have caused reversion back to normal "magneto only" operation.

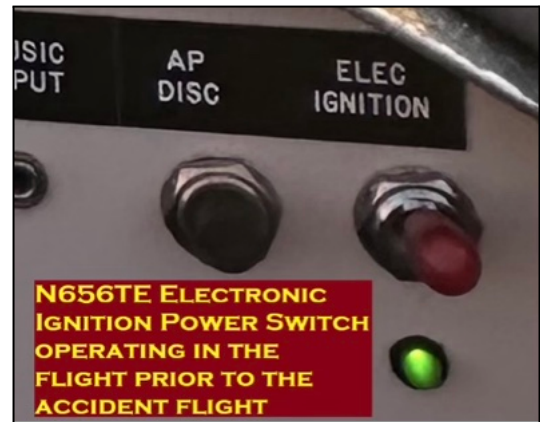
Figure 2:

1. The pilot must correctly determine that a G3i Series-2 failure is the cause of the engine partial or full power loss (this is determinative and non-trivial).
2. The pilot must switch the G3i system to the "**OFF**" position using the electronic ignition power switch (which on N656TE was on the top right corner of the instrument panel, away from the pilot). Only then would the magnetos revert to operating in their original mode.

Passenger photo of N656TE IP on day of accident

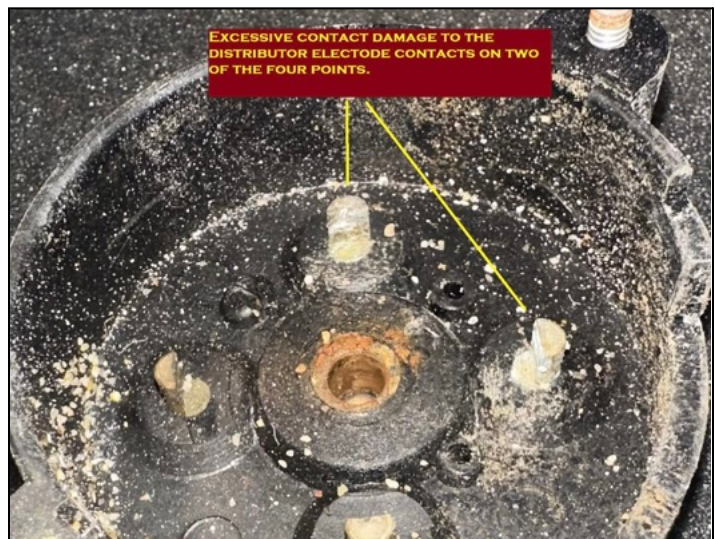
Figure 3:
Distributor contact damage

evaluate all components of the interior of the magnetos. We were able to determine that the distributor electrode brush contacts were substantially damaged as compared to new ones. This damage could have been caused by lack of magneto maintenance or by excessive energy transfer from the G3i system, which puts out ~3X the energy of a standard magneto, but passes that energy through the magneto components.

You can see the damage to the distributor contact areas in Figures 3 through 6.

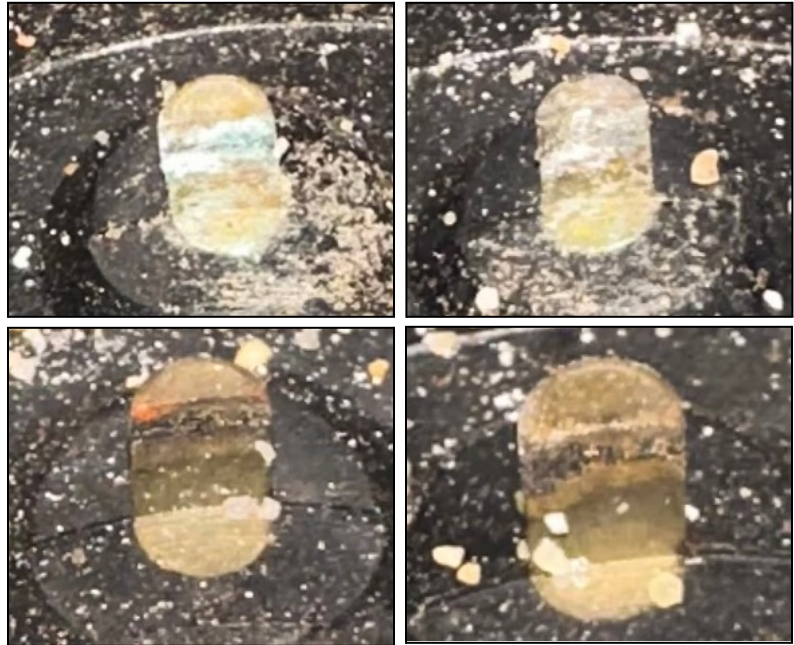
Figure 4:
Closeup of distributor contact damage

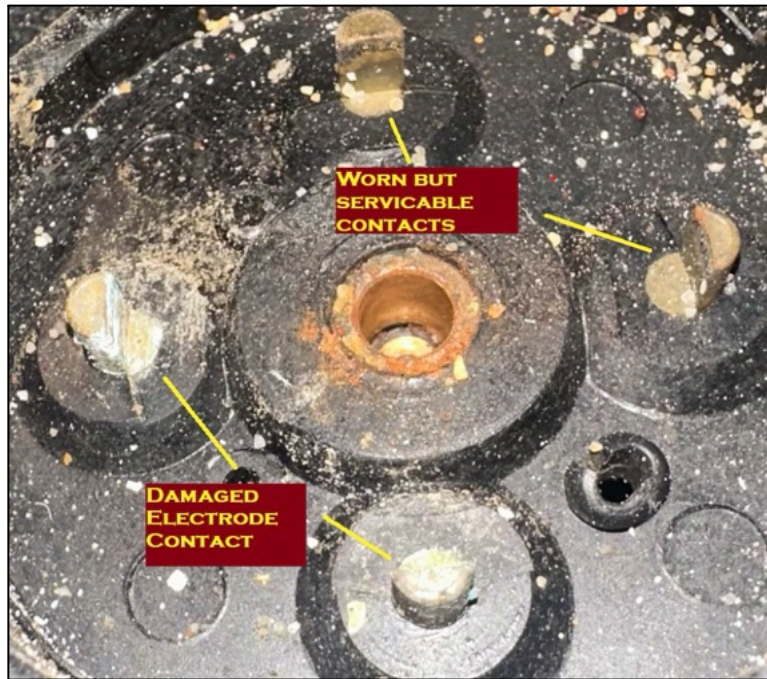
Figure 5:
Two distributor contacts damaged

Both distributor caps had been previously disassembled and inspected with the exposed components placed unassembled and loose with the wreckage prior to our examination, with no labeling. Therefore we do not know which cap was associated with which magneto.

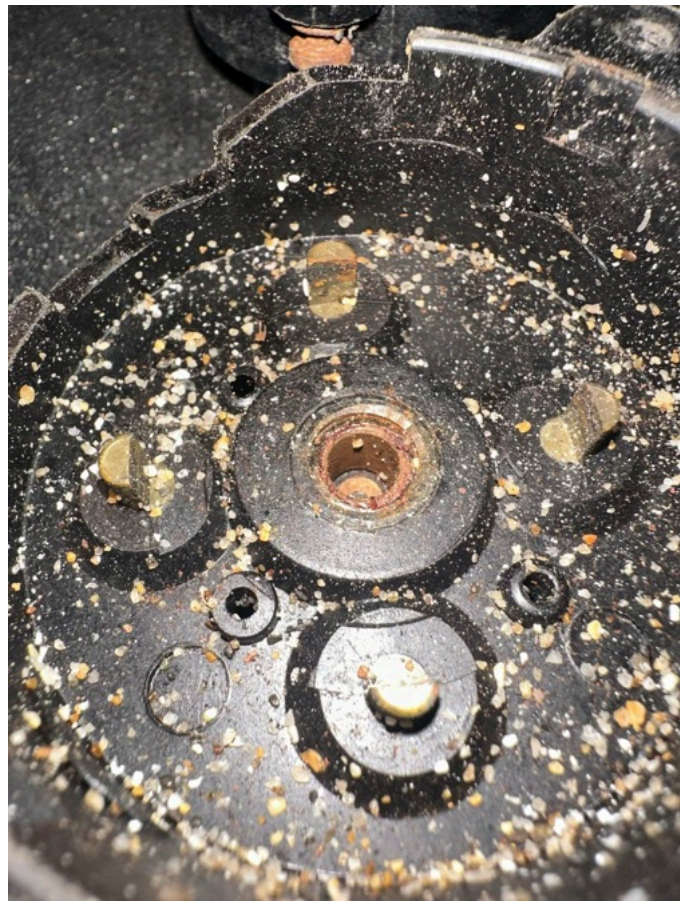
Figure 6:
Second distributor cap - worn, but more serviceable contacts

This information and analysis suggests that either a left magneto or G3i electronic ignition system failure could account for a large power loss as well as a subsequent total loss of power. An ignition system failure of these kinds is the most likely accident cause (although even with this knowledge, the probability of this being the cause may still only be in the 50% - 80% range).

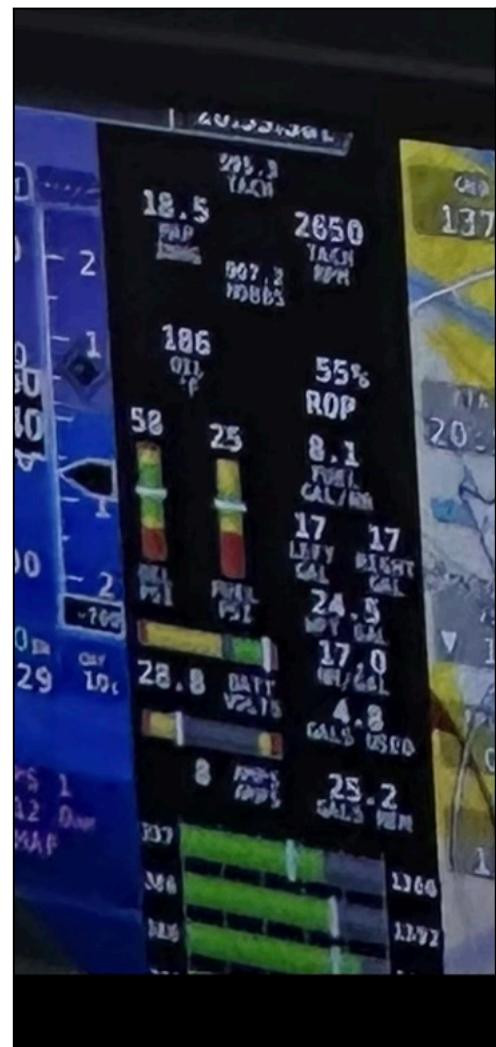
At the time of the accident, the aircraft had approximately 17 gallons of fuel in each tank as evidenced from the analysis of a photo taken by the rear passenger. Fuel flow indicated 8.1 GPH at 2,650 RPM, which is normal for a Lycoming O-360. Fuel pressure was 25psi. The electric backup fuel pump did not appear to be turned on. Given the fuel load upon landing, it's unlikely the pilot would have taken on fuel at Half-Moon Bay - a potential source of contamination. The weather conditions did not include precipitation so it's unlikely that water was introduced through leaky fuel caps.

Figure 7:
Screenshot of fuel information
