## THE CANARD PUSHER

NO. 14 OCT. 77

NEWS OF THE VARIVIGGEN (very vig-in) and VARIEZE (very easy)

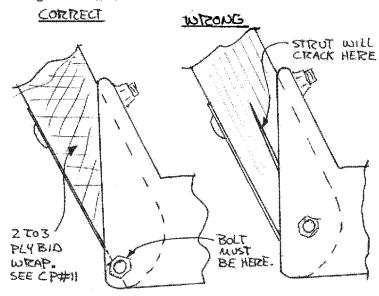
VARIEZE LANDING GEAR- We are asking all of you to make a change to the main gear mounting tabs. This change is not based on any problem with N4EZ nor any drop test result. N4EZ now has about 500 landings, some of them at gross weight and a few of them quite hard. There has been no deterioration of the gear orattachments, so it is a bit confusing to us to learn that 3 or 4 of the homebuilt Ezs now flying have had failures. One was a complete failure of the tab that allowed Cy Mehlings gear to rotate forward, dropping his airplane on its belly while taxing. Others were discovered before they completely failed. In one case the bolt or spacer had worked in the tab enough to allow the inside and ouside pad layups (page 18-2) to move relative to each other, thus partially peeling the tabs from the strut and making the strut loose. Because these failures are apparently not isolated cases but are affecting a large percentage of the builders we recommend that you update your gear to the configuration shown below before you taxi or takeoff.

inch edge distance all around the tab. Cy Mehling's tabs were only 0.33" at the point of failure.

Since I have been alerted to the failures in this area I have been keeping a close look at the tabs on N4EZ. The forward tabs are difficult to see, so I made a 3-inch diameter hole in the rear seat bulkhead immediatly in front of each tab, to allow inspection. I recommend that you make these holes in your airplane. They do not show, since they are covered by the back seat cushion. Use a pin router or hole saw.
