THE CANARD PUSHER

No. 57

October, 1988

RUTAN AIRCRAFT FACTORY, INC.

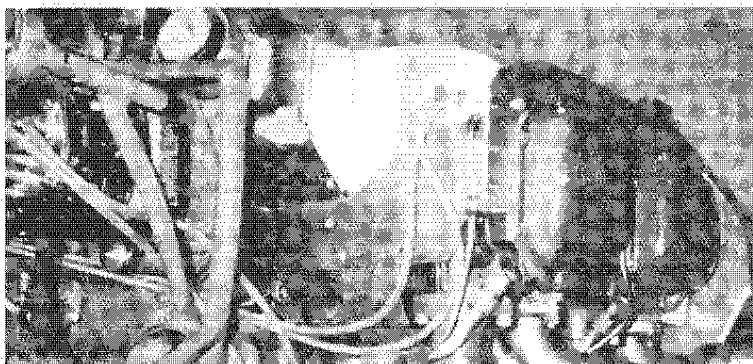
Baffling! .032 6061-T6 aluminum. This is how it should be done. The neoprene/asbestos material still has to be installed.
