PROP LOSS – DESERT CENTER

Emergency Landing in a COZY MKIV

Marc J. Zeitlin

July 26th, 2007

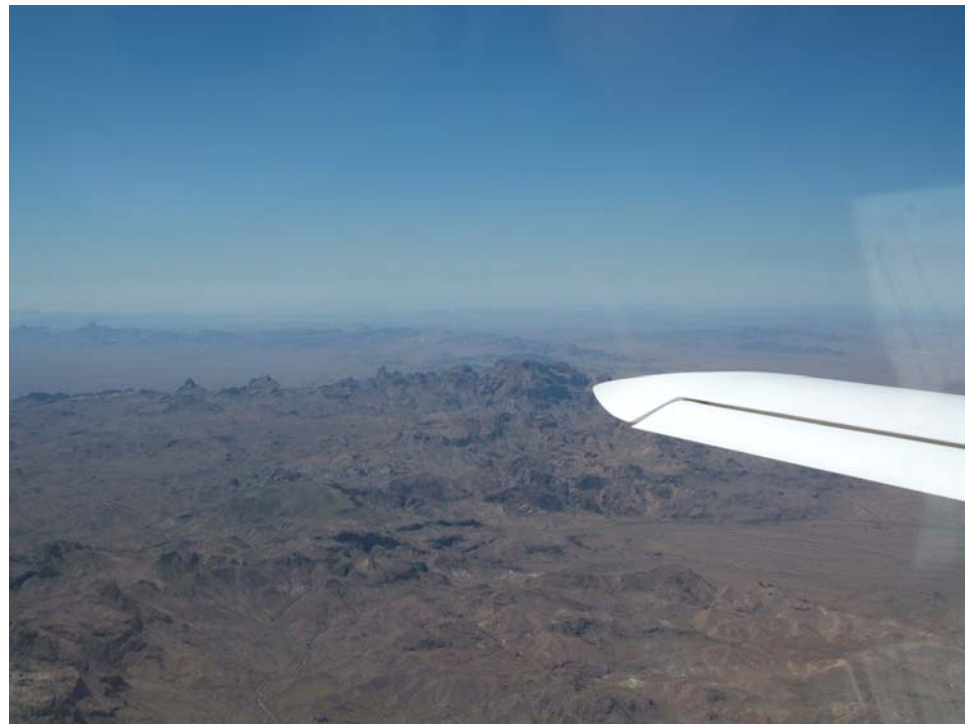
Early Stage of Flight

- First 45 minutes – slight vibration on and off
- Next 5 minutes – vibration builds, but still relatively slight and intermittent

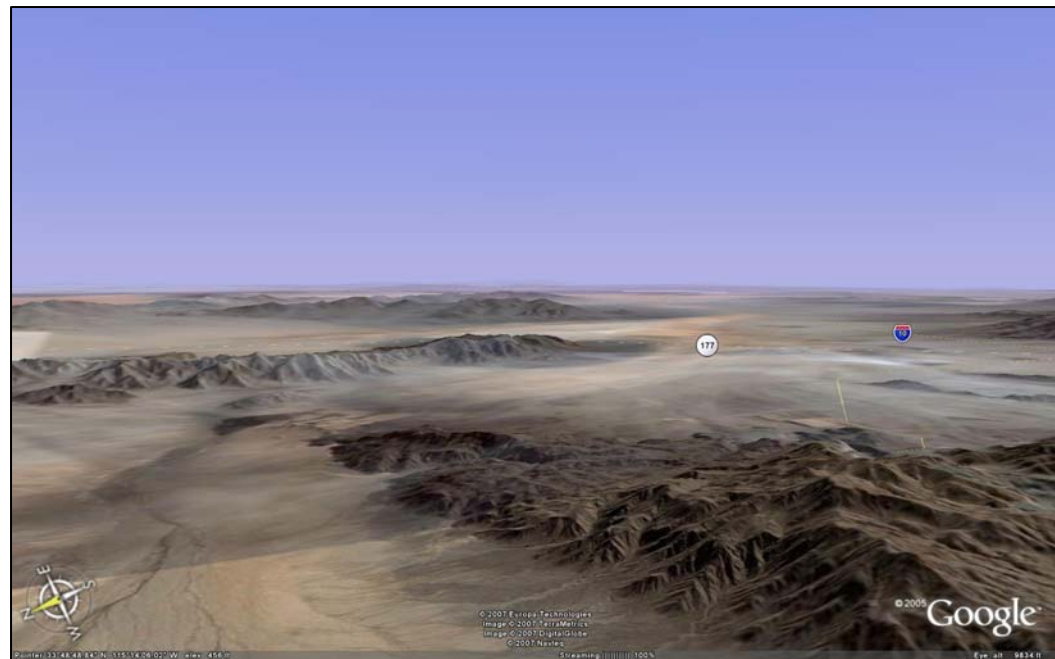
Propeller Loss

- **BIG FREAKING BANG!!!!!!**
- Bolts Breaking or prop hitting winglet?

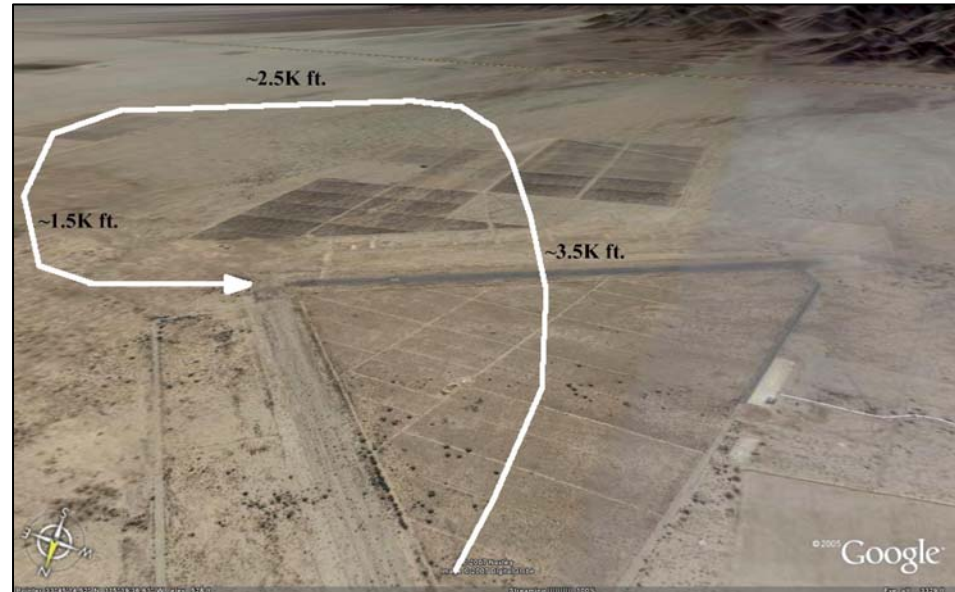
Landing

- After 11 minute glide, arrive at Desert Center (L64) 2K ft. above pattern altitude
- Check windsock and airport layout – pick landing direction
- Crosswind at 1500 ft. above pattern altitude – perform wide left pattern
- Tell Deanie we'll make a normal landing
- Drop gear on downwind, landing brake on base, retract landing brake on final
- Touch down 1000 ft. down 4200 ft. runway, roll to end and off onto taxiway
- Shut down and open canopy
