# THE CANARD PUSHER

No. 60

July 1989

RUTAN AIRCRAFT FACTORY, INC.  
Building 13, Airport  
Mojave, CA 93501  
805-824-2645

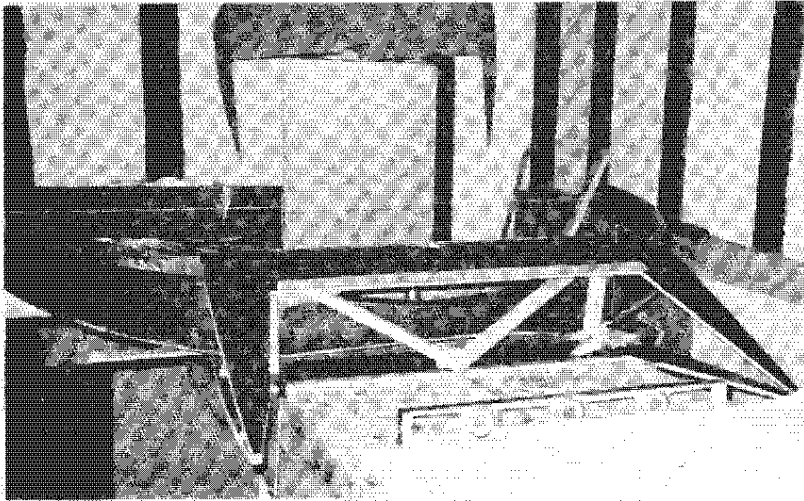
ER GROOTERS sent in these shorts of his method of installing the gear in his Defiant. Jigging for installation of the main gear attach tabs.

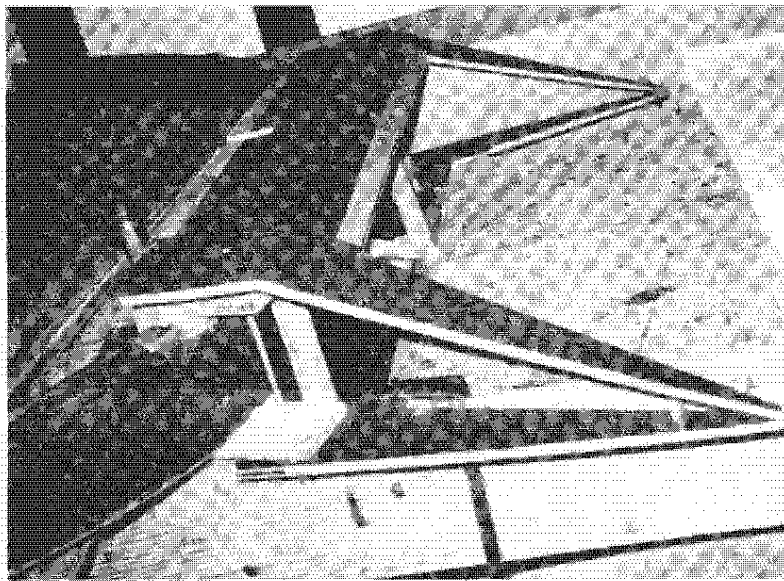
MAIN GEAR bulkheads remain jugged together through installation in the fuselage. A great idea!

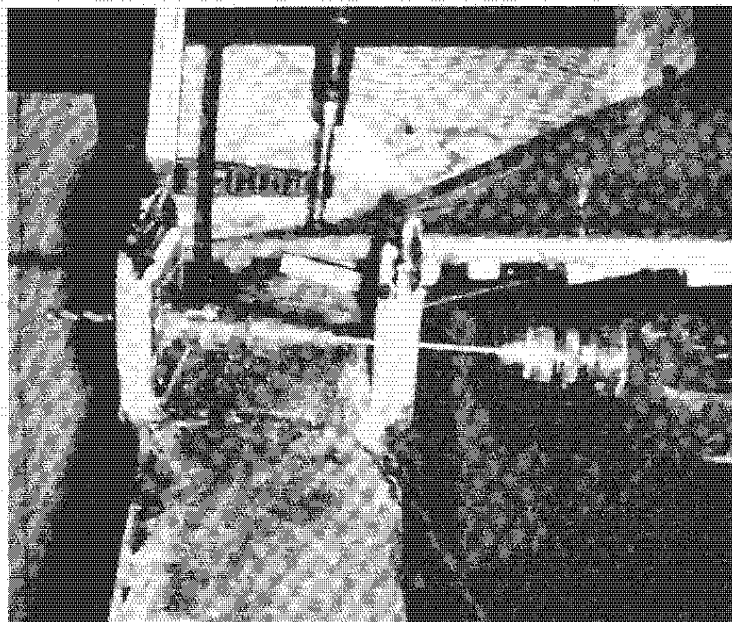
Using a hole saw to open the pilot holes in the attach tabs.

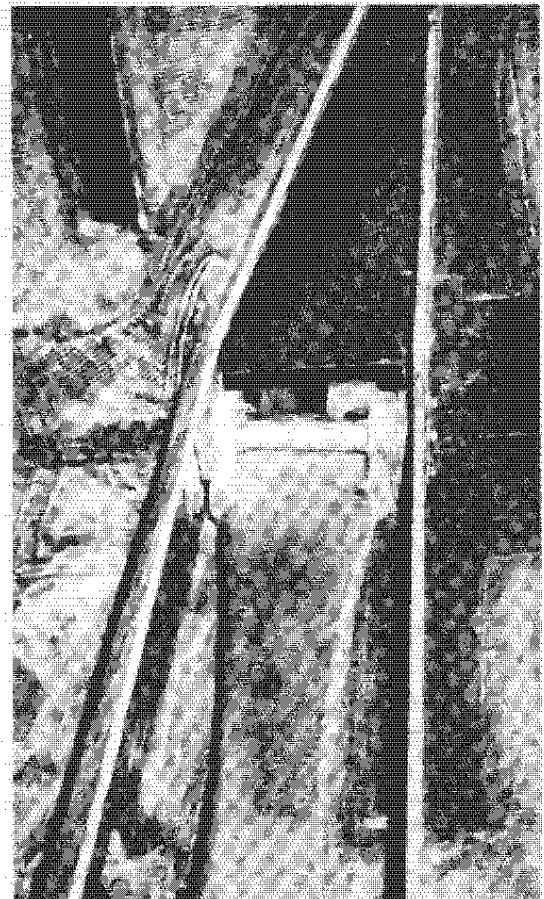
The entire main gear/bulkhead assembly is taped into the fuselage.

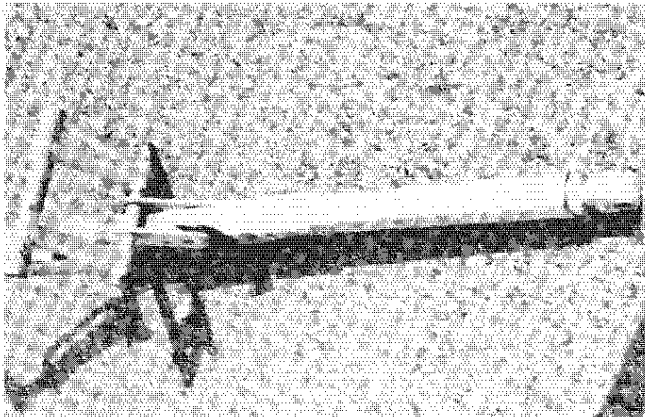
Don Foreman's new NG-1/NG-2 nose gear strut.

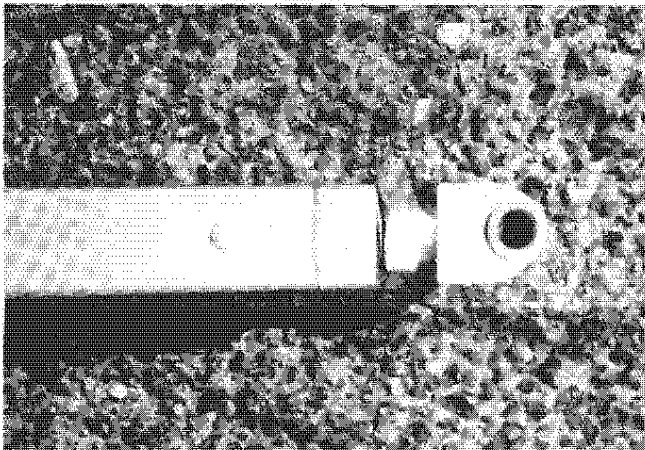
Detail of the end of Don Foreman's NG-1. Note: Heavy duty adjustable pivot end. Don's own design and a good idea - makes it much easier to install.

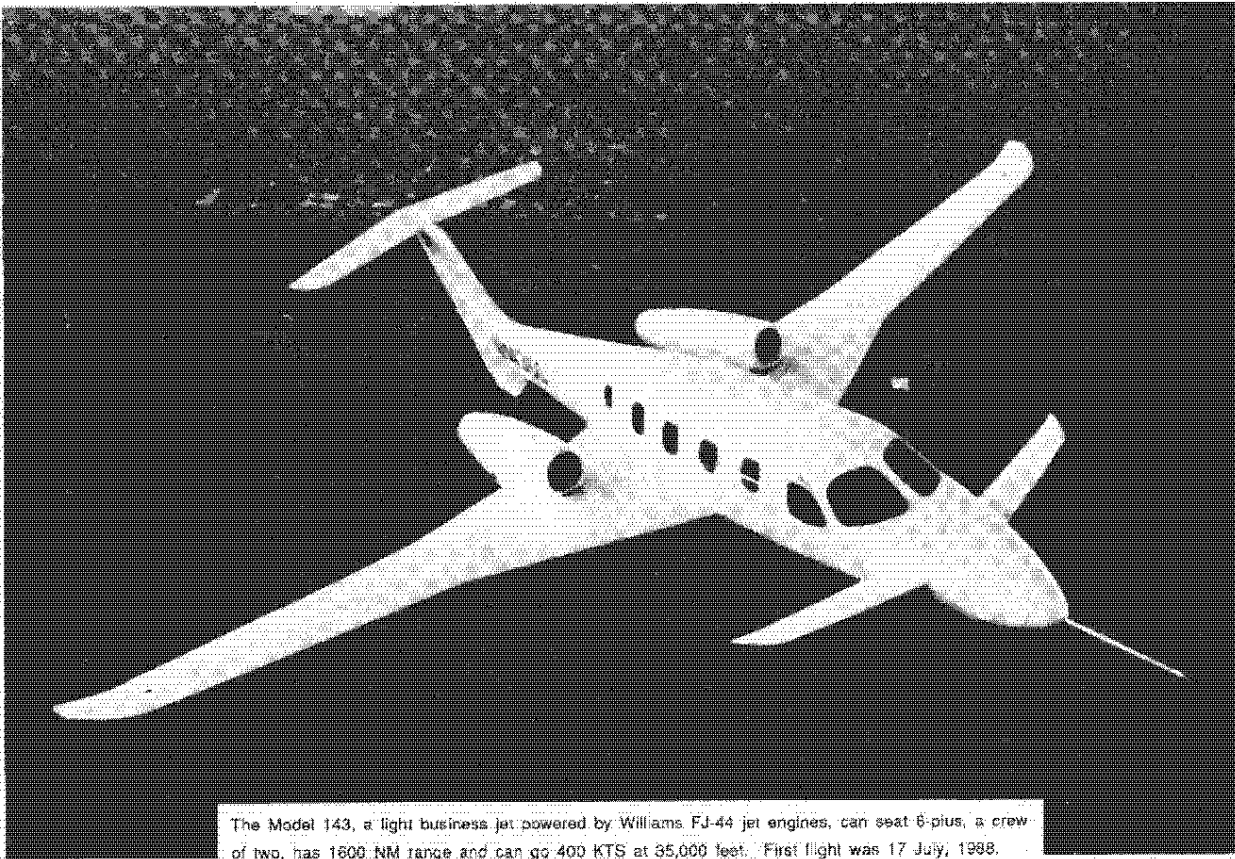
The Model 143, a light business jet powered by Williams FJ-44 jet engines, can seat 6-plus, a crew of two, has 1800 NM range and can go 400 KTS at 35,000 feet. First flight was 17 July, 1988.
