THE CANARD PUSHER

No. 49

July 1986

RUTAN AIRCRAFT FACTORY INC.
Bldg 13, Airport,
Mojave, Ca 93501
(805)824-2645

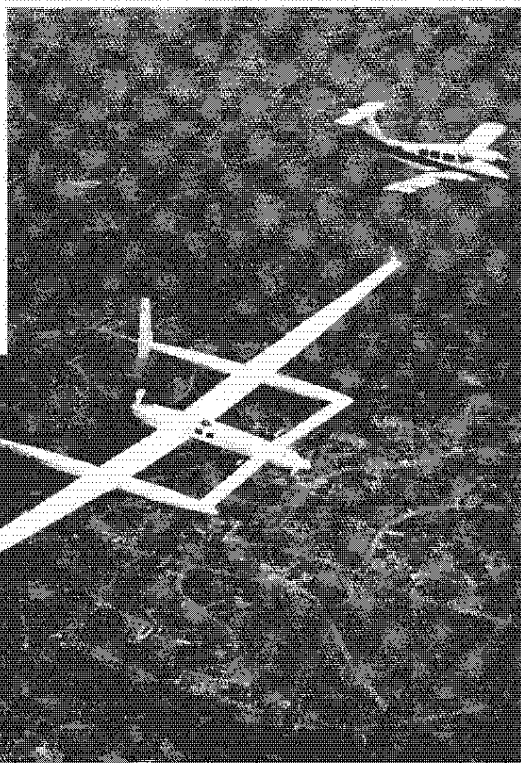
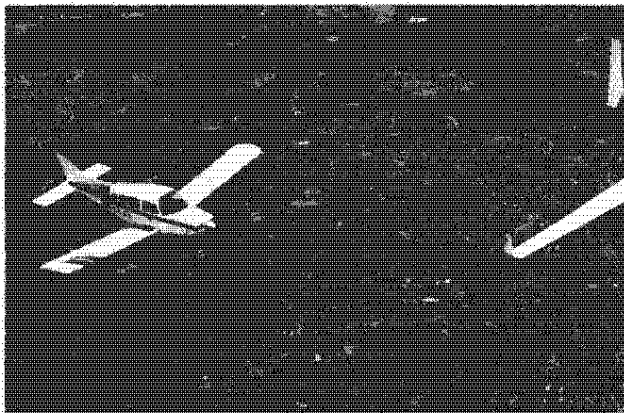
"Coming Home" - Dick and Jeana in the Voyager over Tehachapi on her way to a triumphant reception at Mojave after flying more than 10,000 nautical miles, non stop, non refueled, over a four day, five night flight. Bruce Evans flies chase in a Sierra, while Burt and Mike fly the left wing in a Duchess.

As we go to press, Dick and Jeana have successfully completed their flight up and down the California Coast. They have set a "provisional" closed course distance record of approximately 10,074 nautical miles (11,600 statute miles) in 110 plus hours of flight. "Provisional" because it has not been officially ratified at this time. The flight was essentially flawless. The pilots were in excellent shape when they climbed out of the airplane and they are pleased with the results. After landing, the Voyager was carefully weighed and it had, in fact, enough fuel on board to have gone on to New York with fuel to spare!! An outstanding job well done.
