THE CANARD PUSHER

No. 76

July 1993

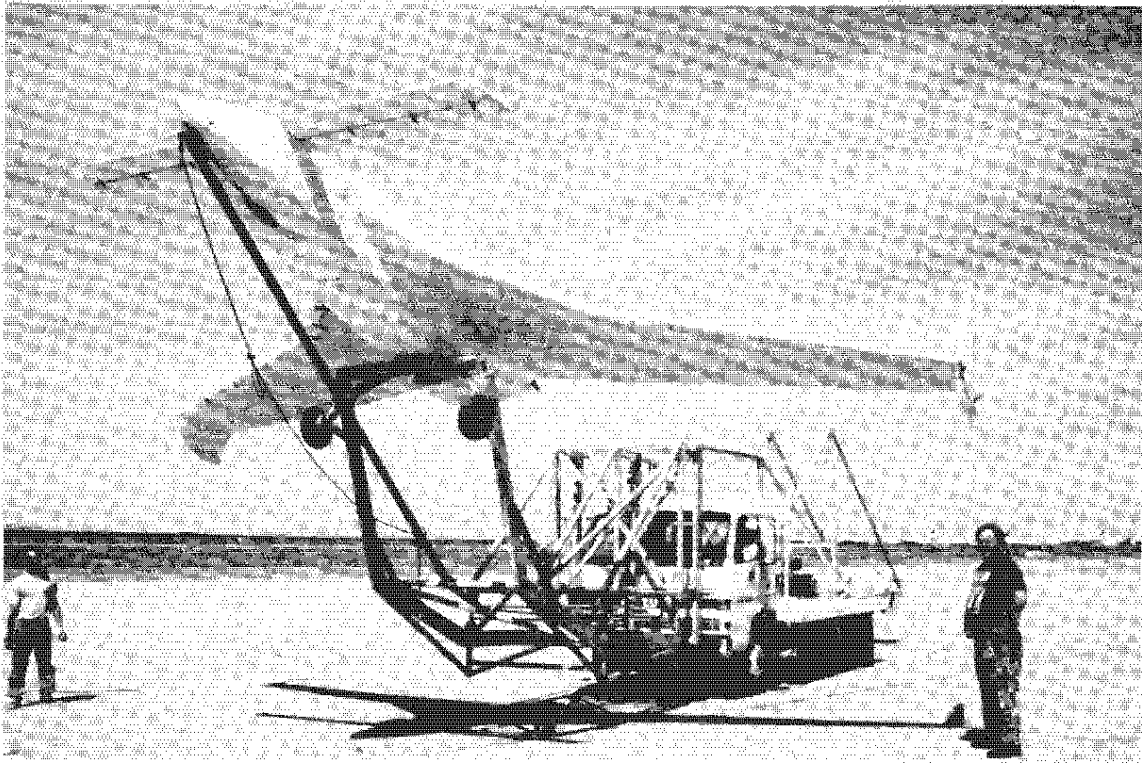
Data Symbols are for aft CG limit F.S.=103
All Data are for zero elevator position.

See pages 2 and 3 in this CP for article "Truck-EZ Test "

Donald Douglas lent us his beautiful plans-built Long-EZ so that we could generate the full scale, angle-of-attack data using this "Truck-EZ" rig. Many thanks, Don.
