CANARD PUSHER

OCTOBER 1996

RUTAN AIRCRAFT FACTORY

Burt & Mike report Boomerang characteristics

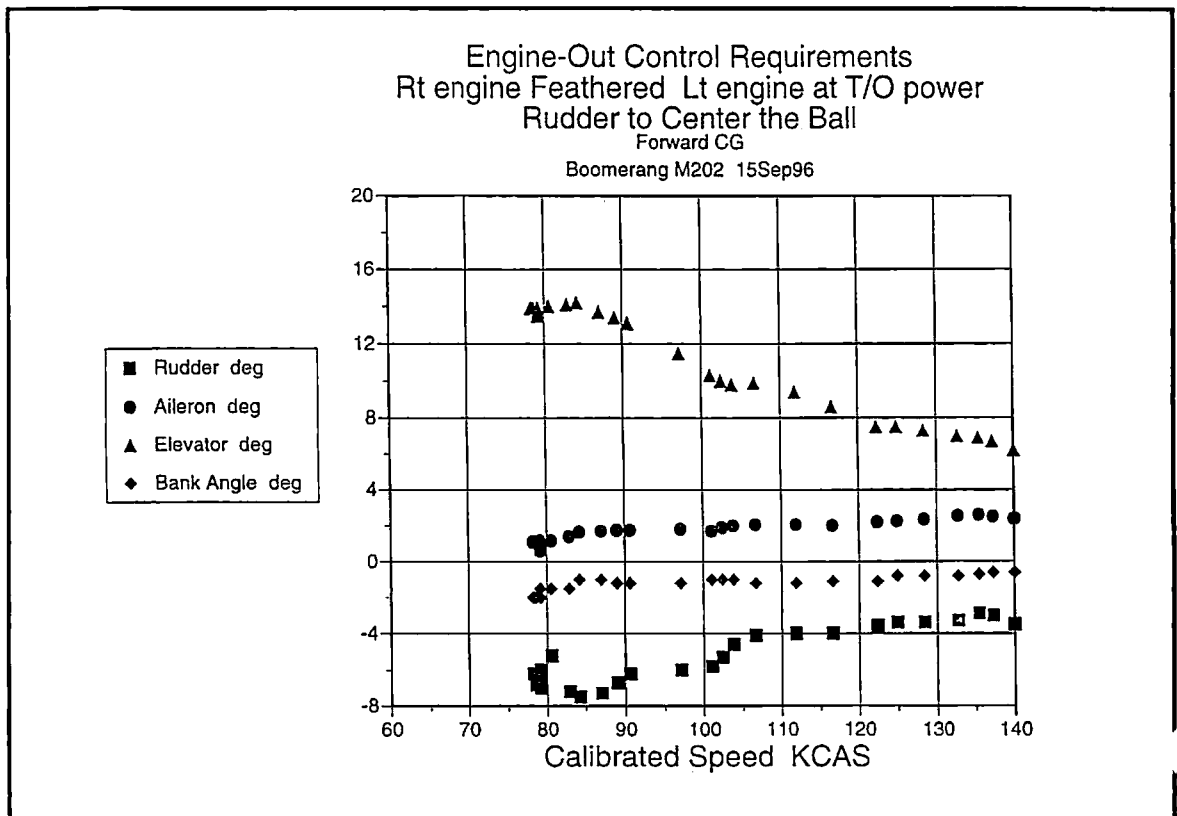
Figure 6

Engine-Out Control Requirements
 Rt engine Feathered Lt engine at T/O power
 Feet-on-the-Floor
 Forward CG
 Boomerang M202 15Sep96

Figures 4 - 7 illustrate the complete data for the Boomerang when flown with one engine inoperative. Note that if the pilot centers the ball, more than twice as much rudder is required to handle an engine-out if the left engine is failed than to handle an engine-out if the right engine is failed. This appears backwards since the Boomerang's left engine is at butline -56 and the right engine is at butline only +32. The reason for this is primarily the P-effect which causes a thrustline of engines to move to the right as angle-of-attack increases. Thus, even though the Boomerang looks geometrically asymmetric, it is not geometrically asymmetric enough in order to make its engine-out control symmetric. In other words, to make the airplane symmetric at minimum speed you would have to move the left engine even further from the fuselage.

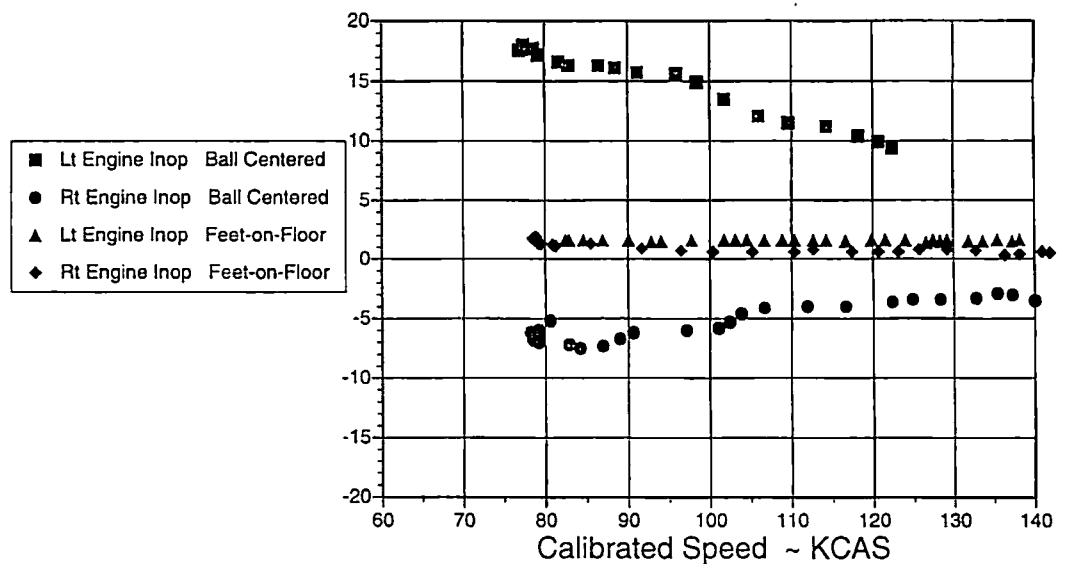
Figure 8 summarizes the rudder requirements for all four maneuvers.

Engine-Out Rudder Requirements
 Boomerang M202 15Sep96 fit
